# PERI Rental Criteria

## DOMINO

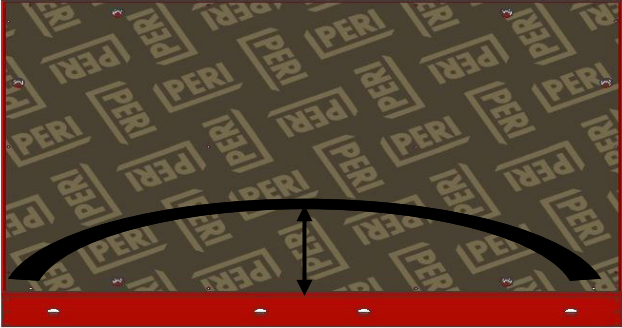
<p><b>24.01 Element bent</b></p> <ul style="list-style-type: none"> <li>■ &gt; 8 mm</li> </ul>

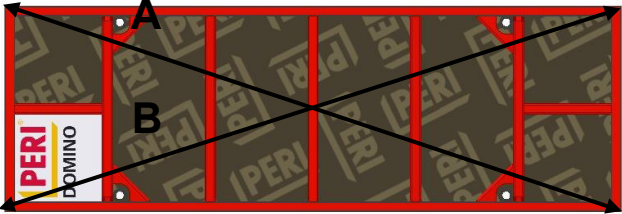
<p><b>24.02 Element is warped across the diagonal line, control by diagonal measurement</b></p> <ul style="list-style-type: none"> <li>■ Difference A to B &gt; 5 mm</li> </ul>

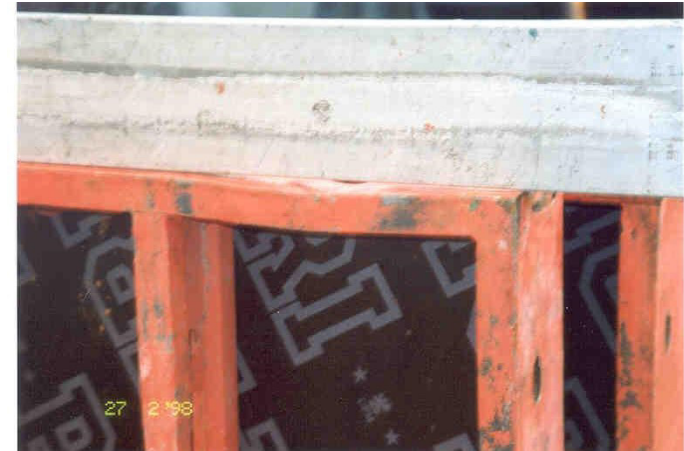
<p><b>24.03 Profile dented</b></p>	<p>

Afterwards control of welding         </p>	<p>

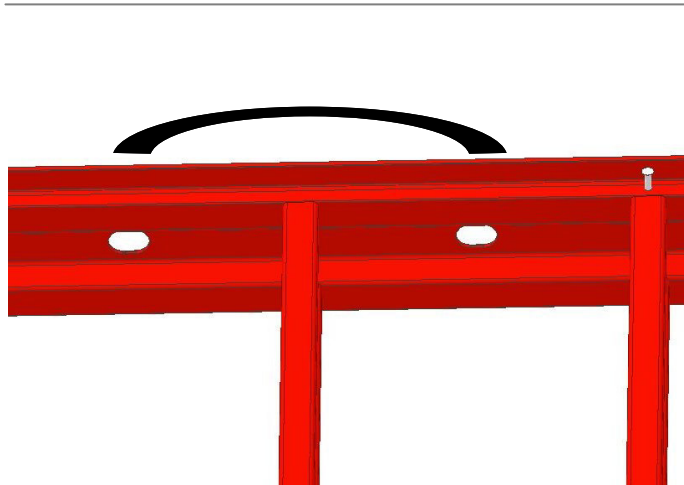
<p><b>24.04 Profile edge dented</b></p> <ul style="list-style-type: none"> <li>■ ≤ 3 mm</li> <li>■ &gt; 3 mm</li> </ul>	<p>

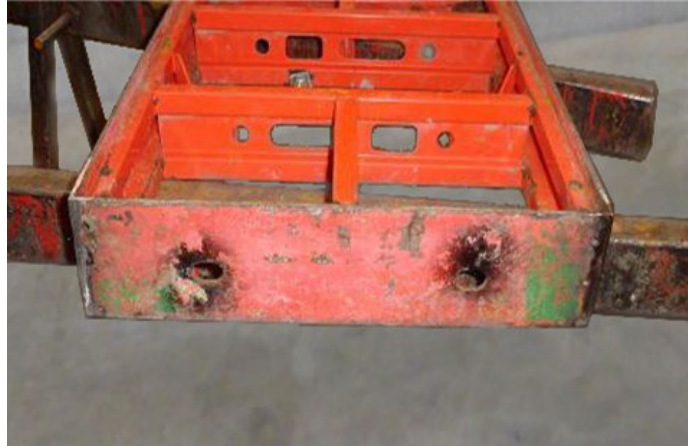
<p><b>24.05 Front profile deformed</b></p> <ul style="list-style-type: none"> <li>■ Connection of DRS lock not longer possible</li> </ul>

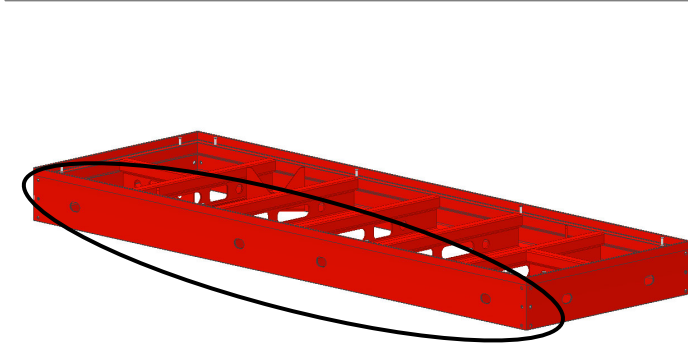
<p><b>24.06 Length profile deformed</b></p> <ul style="list-style-type: none"> <li>■ Connection of DRS lock not longer possible</li> </ul>

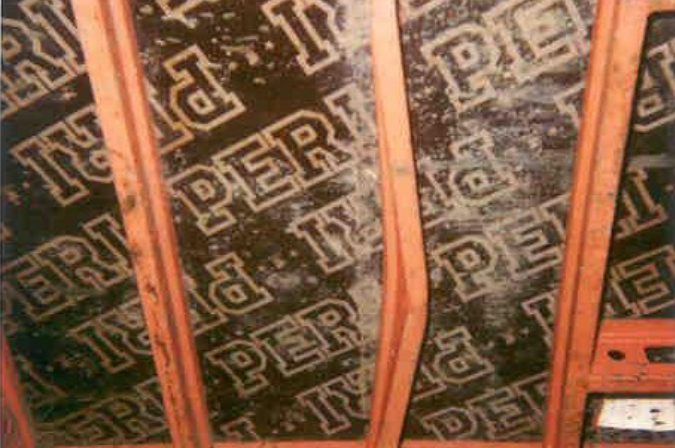
<b>24.07 Brace bent, deformed</b>			
	■ ≤ 3 mm

■ > 3 mm ≤ 10 mm

■ > 10 mm

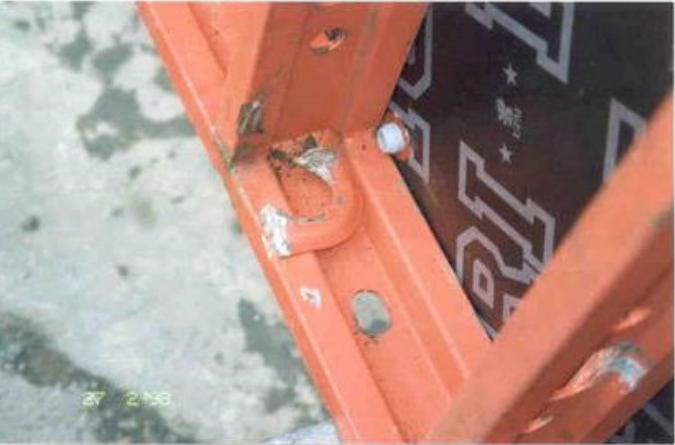
<b>24.08 Anchor steel or anchor lost/ demolished</b>

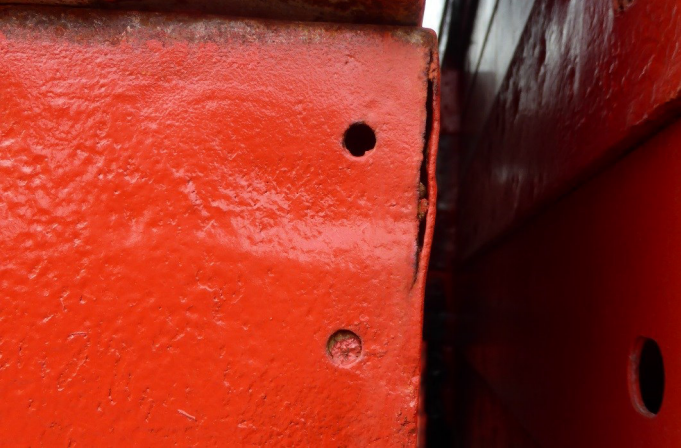
<b>24.09 Welding torn of edge or brace</b>		088028

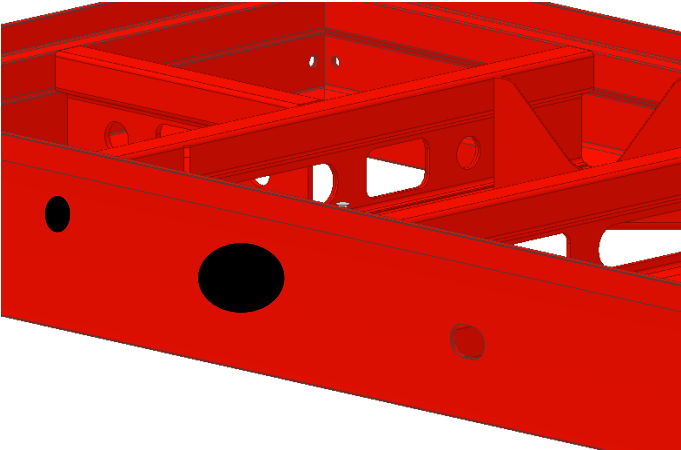
<b>24.10 Holes in profile</b>			
	<ul style="list-style-type: none"> <li>■ <math>\leq \text{Ø } 5 \text{ mm}</math></li> </ul>			
	<ul style="list-style-type: none"> <li>■ <math>&gt; \text{Ø } 5 \text{ mm} \leq 15 \text{ mm}</math></li> </ul>		088028	
	<ul style="list-style-type: none"> <li>■ <math>&gt; 15 \text{ mm}</math></li> </ul>

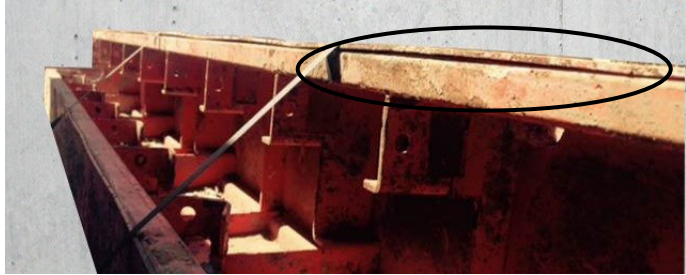
<p><b>24.11 Convex formwork shell</b></p>

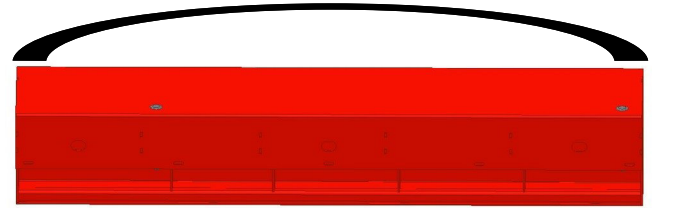
<p><b>24.12 Profile bent</b></p> <p>■ &gt; 8 mm</p>

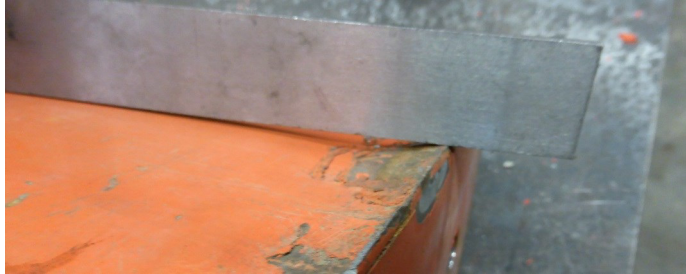
<p><b>24.13 Dent in formwork shell</b></p> <p>■ &gt; 3 mm</p>

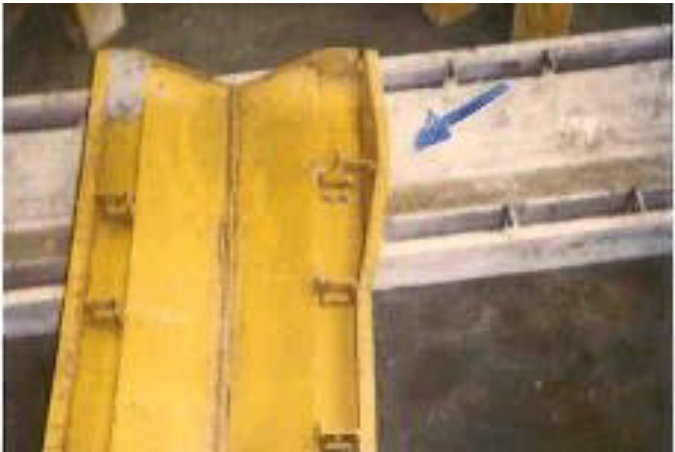
**24.14 Profile bent**

- > 5 mm

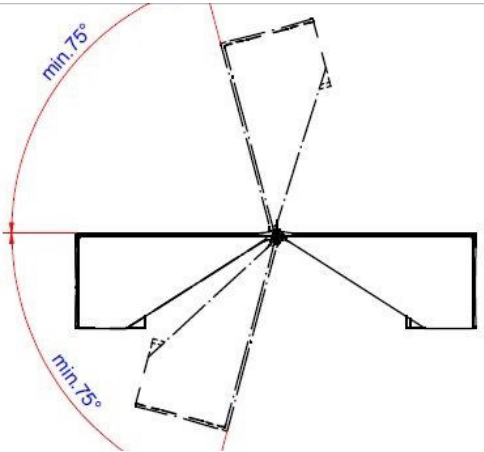
**24.15 Function not satisfied**

- Clean and oil the hinge
- If function is not longer given

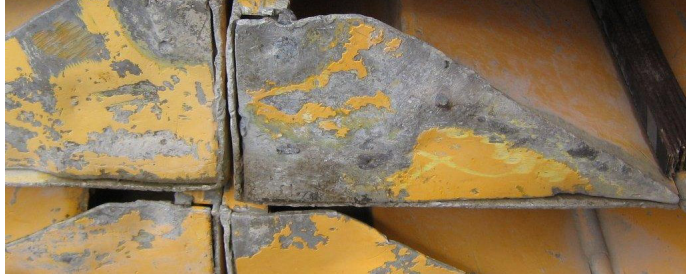
<p><b>24.16 Cover plate deformed, demolished</b></p> <ul style="list-style-type: none"> <li>■ If possible</li> <li>■ Or if irreparable</li> </ul>	<p>

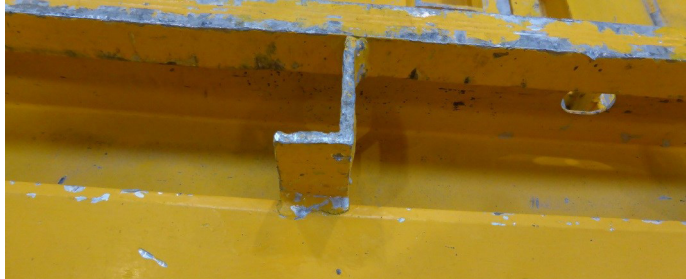
<p><b>24.17 Corner damaged</b></p>	<p>

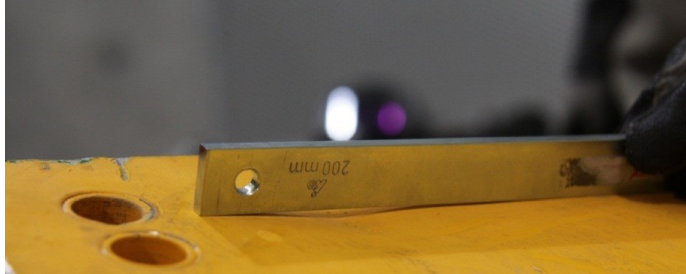
<p><b>24.18 Formwork shell dented</b></p> <ul style="list-style-type: none"> <li>■ &gt; 3 mm</li> </ul>	<p>

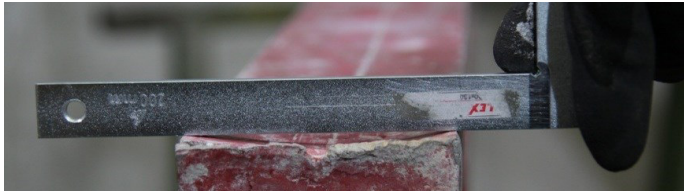
<b>24.20 Concrete surface bent</b> <ul style="list-style-type: none"> <li>■ &gt; 3 mm ≤ 10 mm</li> </ul>

<ul style="list-style-type: none"> <li>■ Or &gt; 10 mm</li> </ul>

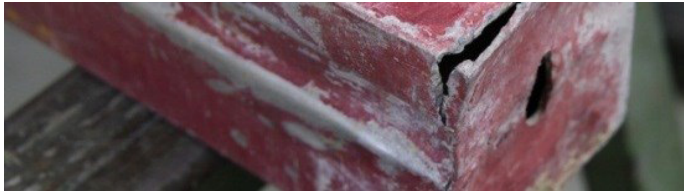
<b>24.21 Deformed cover plate</b> <ul style="list-style-type: none"> <li>■ No damage of welding</li> </ul>

<ul style="list-style-type: none"> <li>■ Or damage of welding</li> </ul>

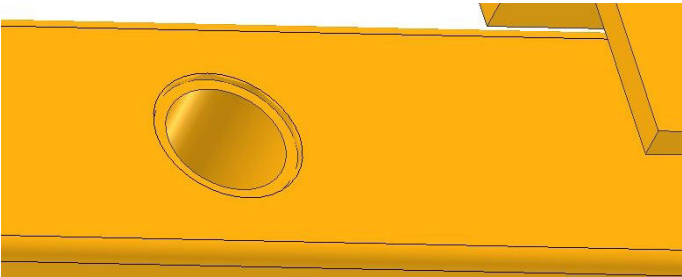
<b>24.25 Tube damaged/ unusable</b>

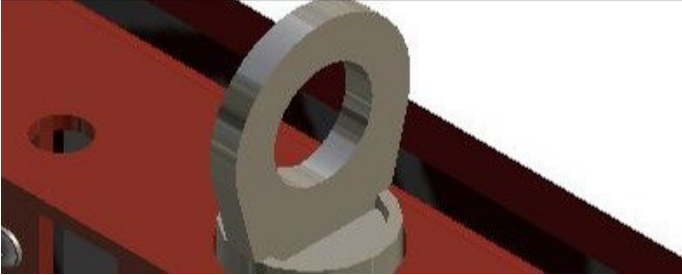
<b>24.26 Crane eye</b>  <ul style="list-style-type: none"> <li>■ Bent</li> </ul>

<ul style="list-style-type: none"> <li>■ Or broken</li> </ul>

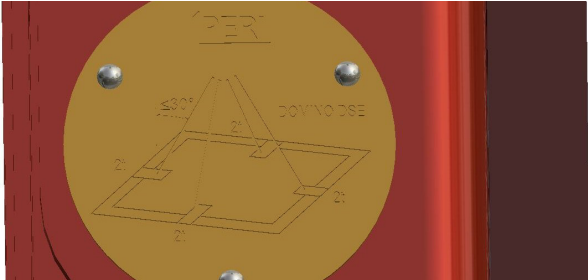
<b>24.27 Type plate unreadable/ lost</b>

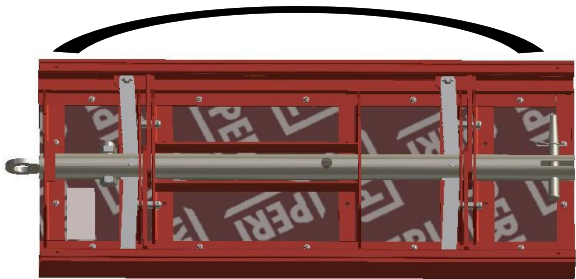
24.29 Rand brace bent

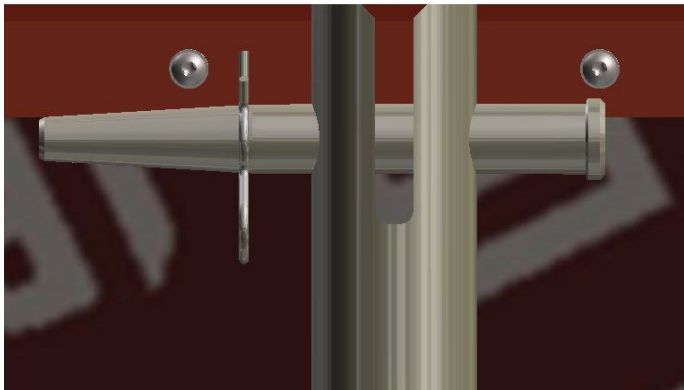
24.30 Pass bolts lost

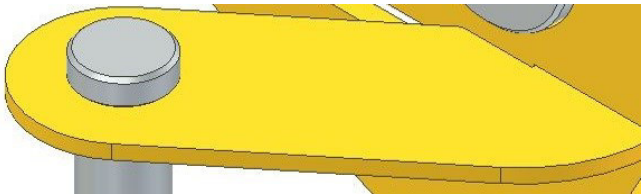
24.31 Claw bent

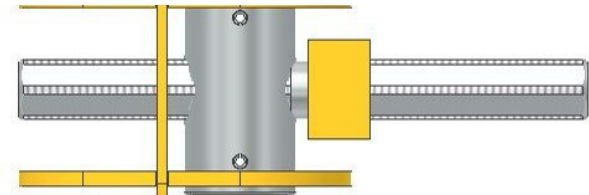
24.32 Spindle/ thread bolts not longer passable

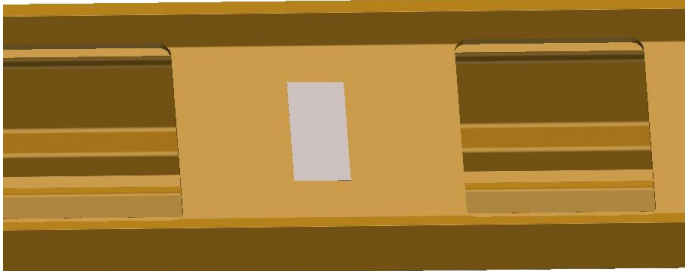
<p><b>24.34 Bar unuseable</b></p>

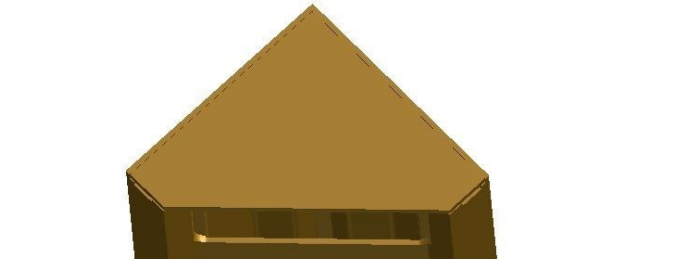
<p><b>24.35 Cover plate bent</b></p>

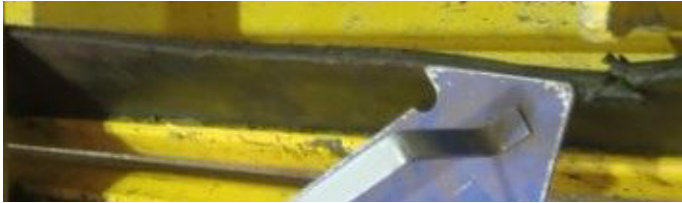
<b>24.36 Sealing profile carved, torn</b> <ul style="list-style-type: none"> <li>■ &gt; 3 mm deep</li> </ul>

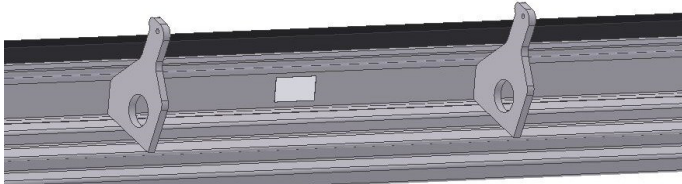
<b>24.37 Hook broken, lost</b>

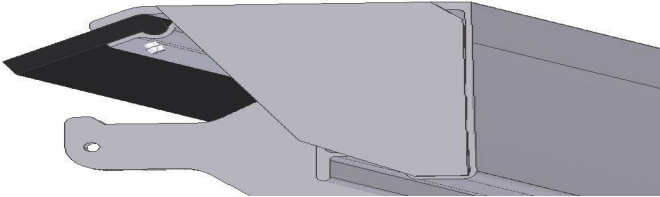
<b>24.39 Cover plate damaged</b> <ul style="list-style-type: none"> <li>■ &gt; 3 mm to ≤10 mm</li> <li>■ Or &gt; 10 mm</li> </ul>

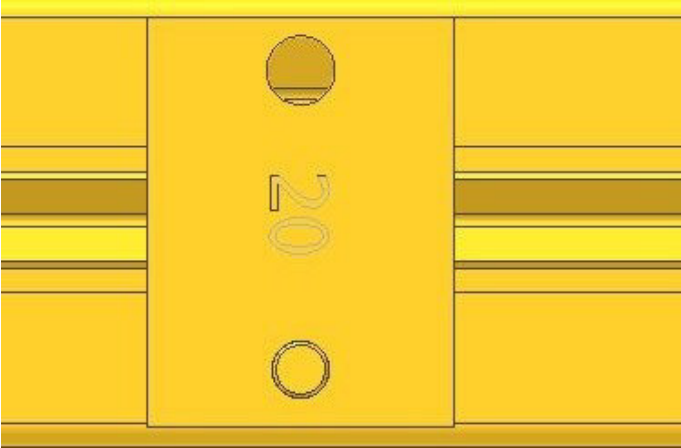
<p>24.41 Plate bent/ unuseable</p>

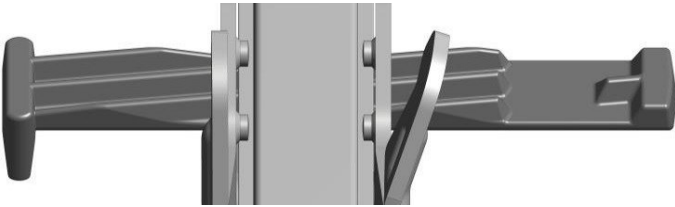
<p>24.43 Retaining claw bent</p>

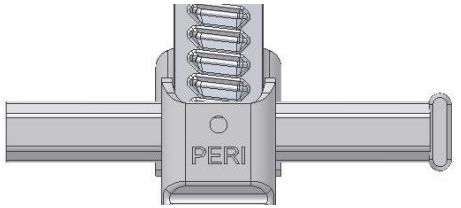
<p>24.44 Wedge not longer passable</p>

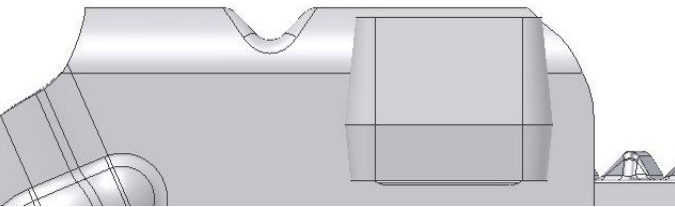
<p>24.45 Hitting surface broken</p>

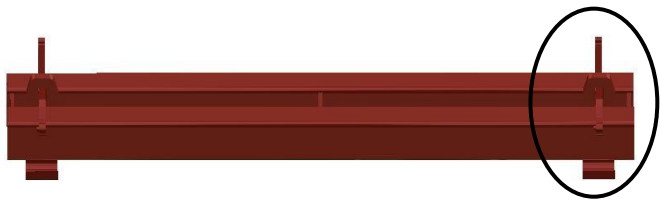
24.48 Guide and wedge defect/lost

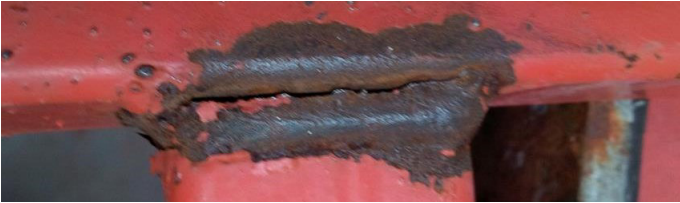
<b>24.50 Cracked welding</b> <ul style="list-style-type: none"> <li>■ Deformation of material</li> </ul>

<ul style="list-style-type: none"> <li>■ Or not deformation of material</li> </ul>

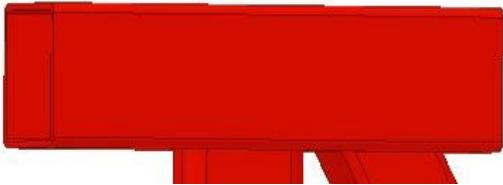
<b>24.52 Vertical tube deformed</b> <ul style="list-style-type: none"> <li>■ If possible</li> </ul>

<ul style="list-style-type: none"> <li>■ Or not possible</li> </ul>

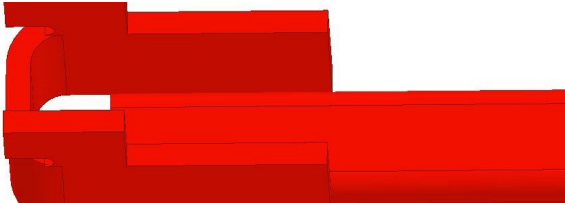
<b>24.53 Bent part</b>

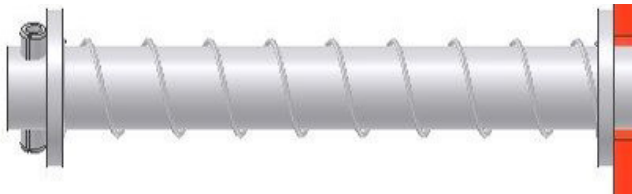
24.54 Spring lost

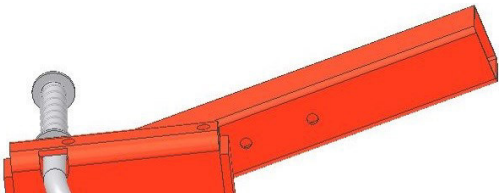
24.55 Basic body bent

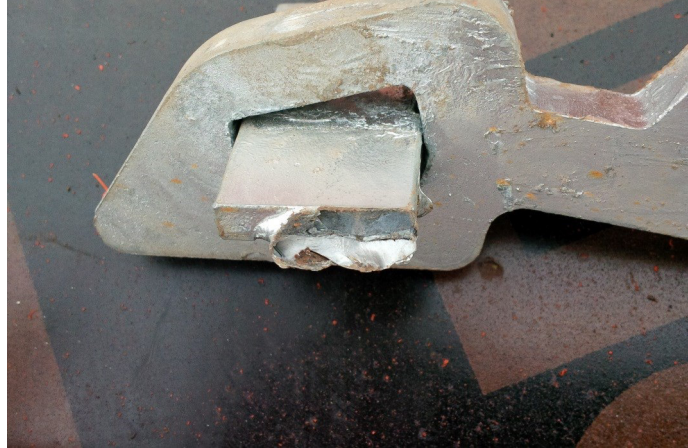
<p><b>24.59 Broken welding at the latch</b></p> <ul style="list-style-type: none"> <li>■ Damaged by force (with damage of the device)</li> <li>■ Or broken without force (no damage of the device)</li> </ul>	<p>

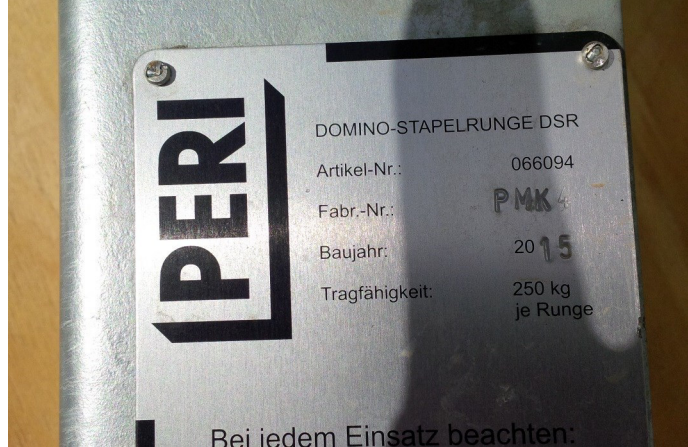
<p><b>24.60 Type plate missing   not readable</b></p>	<p>
