PERI Rental Criteria

MULTIPROP

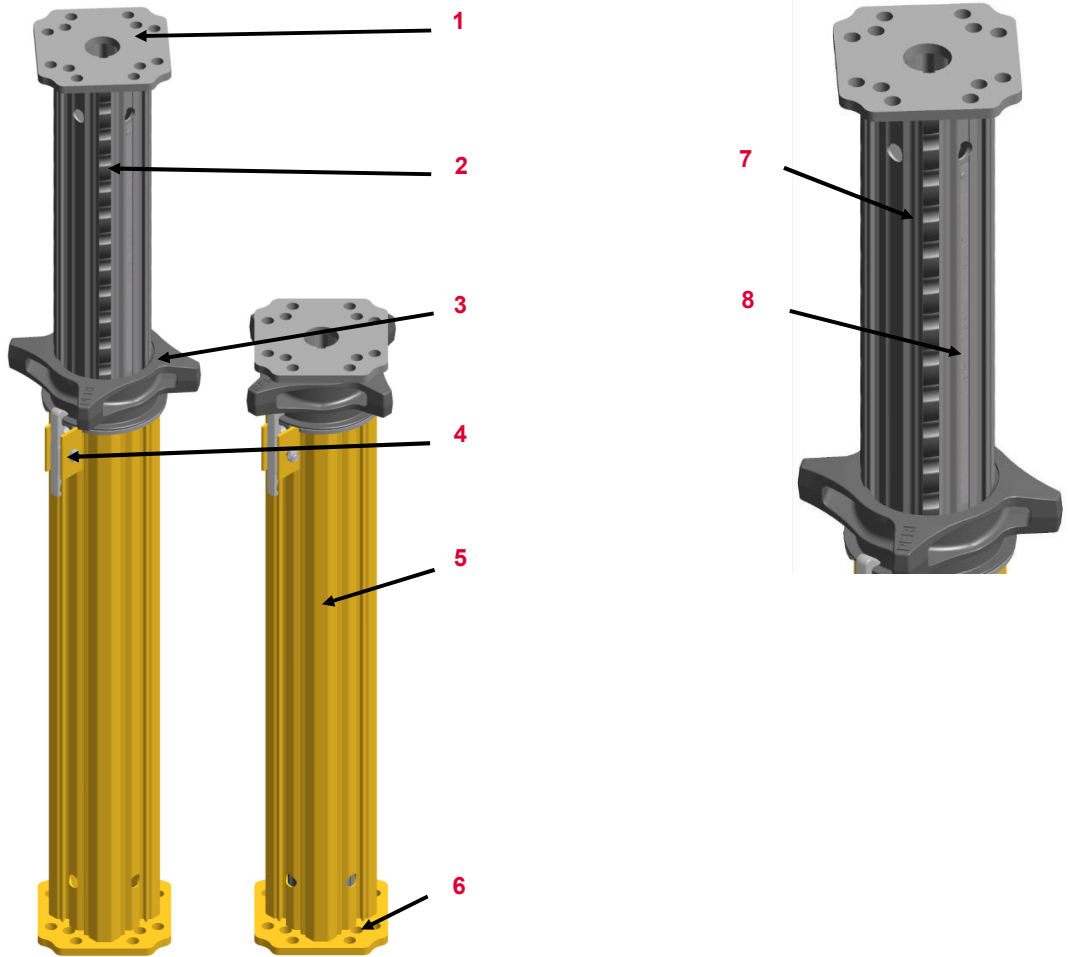
MULTIPROP Prop	No.	Name	Article number
----------------	-----	------	----------------

1	Head plate	
2	Inner tube	
3	Collar	710273
4	Trigger	710418
5	Outer tube	
6	Ground plate	
7	Thread	
8	Flange

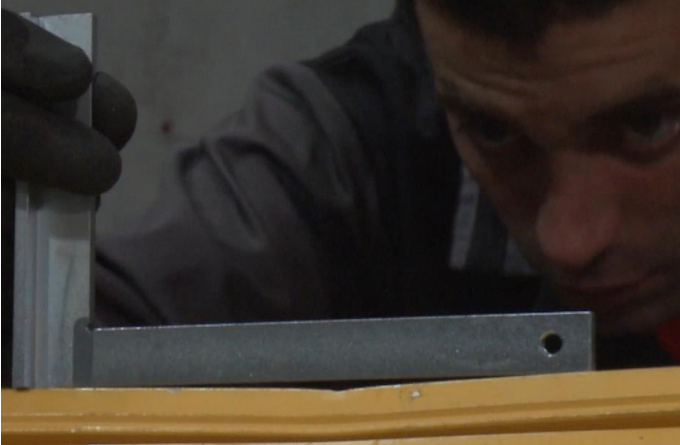
20.05.01 Dent in outer tube			
	<ul style="list-style-type: none"> ■ If tube not moveable

<ul style="list-style-type: none"> ■ Or if outer tube not reparable and if possible

<ul style="list-style-type: none"> ■ Or exchange not possible

Exchange outer tube

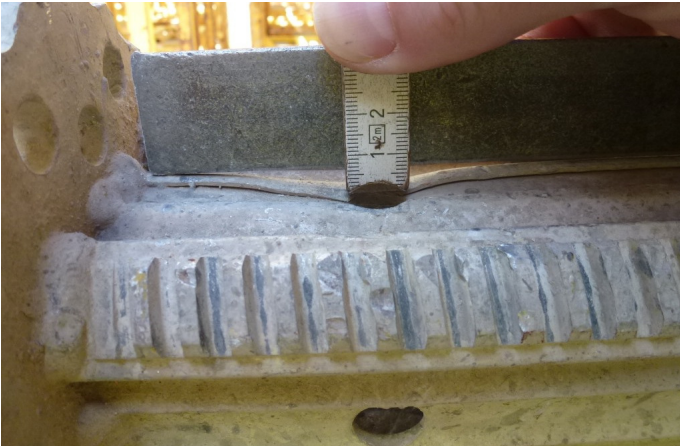
20.05.02 Dent in inner tube			
	<ul style="list-style-type: none"> ■ Tube not moveable

<ul style="list-style-type: none"> ■ Or > 2 mm in thread area and if possible ■ Or > 3 mm in flange area

<ul style="list-style-type: none"> ■ Or if not possible

Exchange inner tube

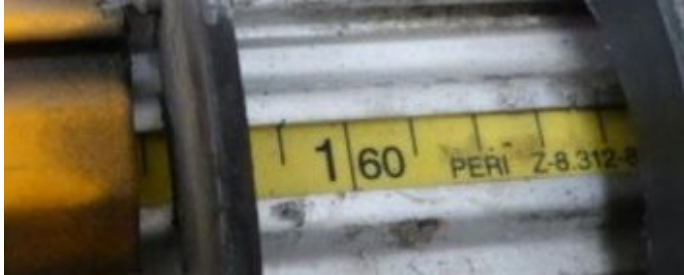
25.05.03 Heavy soiled inner tube or measuring tape <ul style="list-style-type: none"> ■ If possible ■ Or if not possible ■ Or measuring tape missing/ broken

Exchange measuring tape or tube

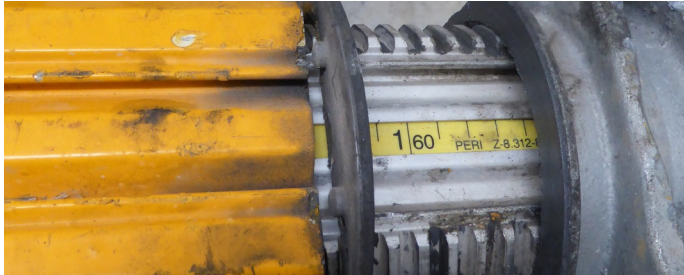
25.05.04 Slide piece loose

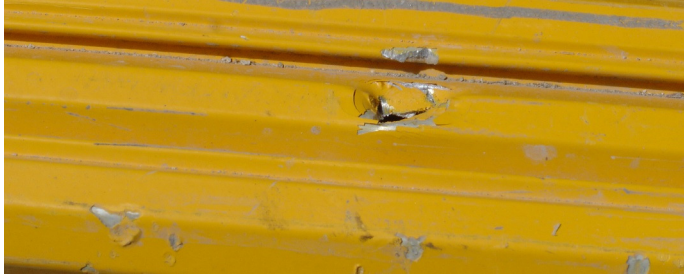
25.05.05 Hole in outer tube <ul style="list-style-type: none"> ■ $\leq \varnothing 5$ mm ■ $> \varnothing 5$ mm

Exchange outer tube

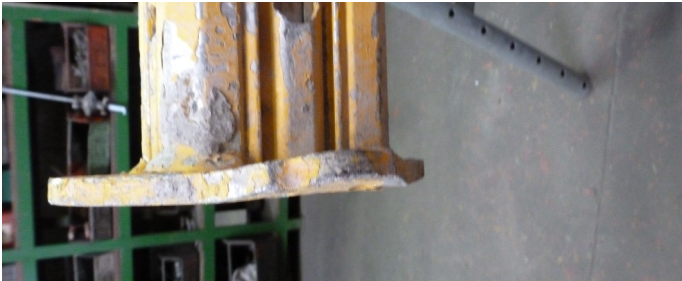
20.05.06 Head or ground plate bent			
	<ul style="list-style-type: none"> ■ Bent until 20 mm

<ul style="list-style-type: none"> ■ Or bent > 20 mm

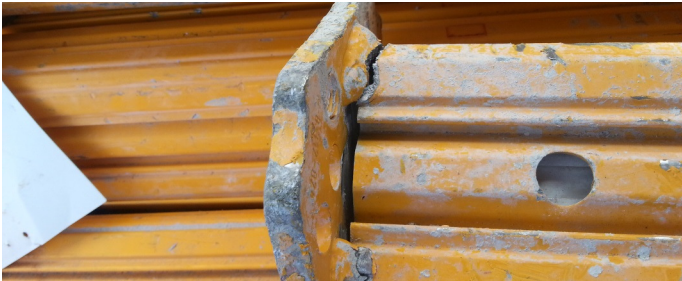
20.05.07 Crack in welding

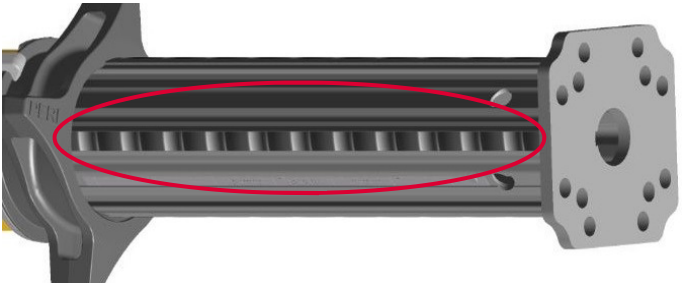
20.05.08 Thread soiled with concrete

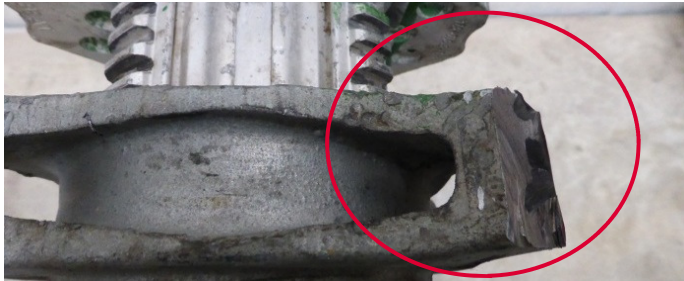
20.05.09 Collar (old version: not trendsetting)			
	<ul style="list-style-type: none"> ■ Parts torn out

<ul style="list-style-type: none"> ■ Or crack in the collar

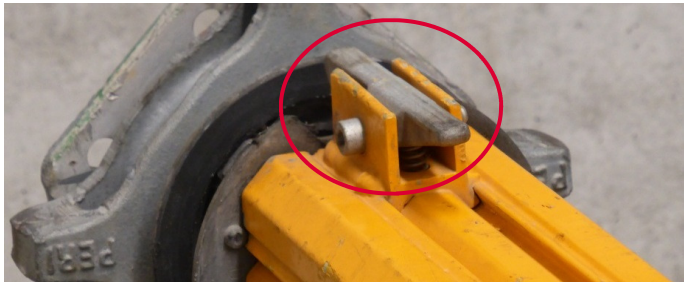
20.05.10 Trigger damaged, function not available

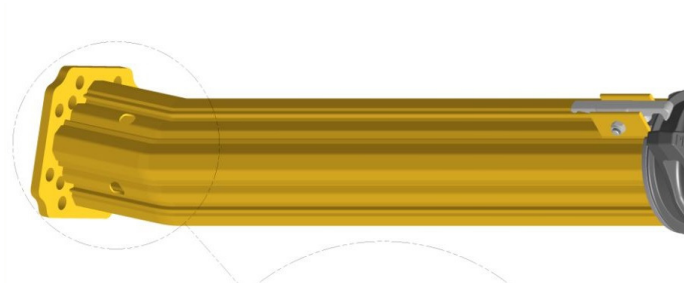
20.05.11 Complete prop bent

<ul style="list-style-type: none"> ■ Tube not moveable

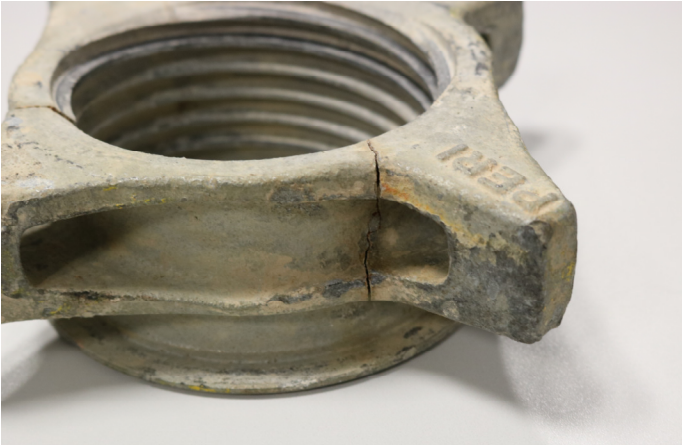
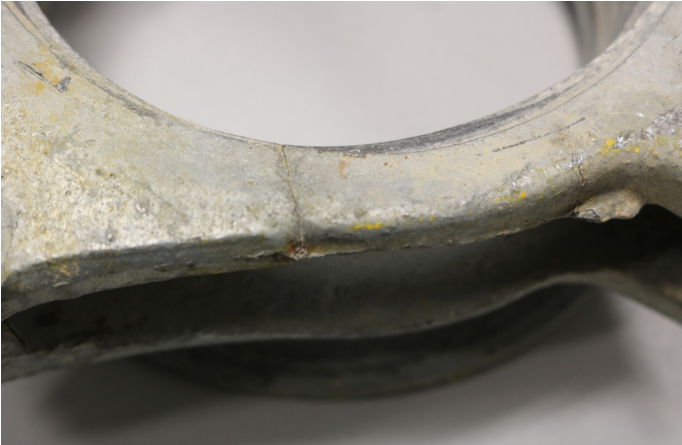
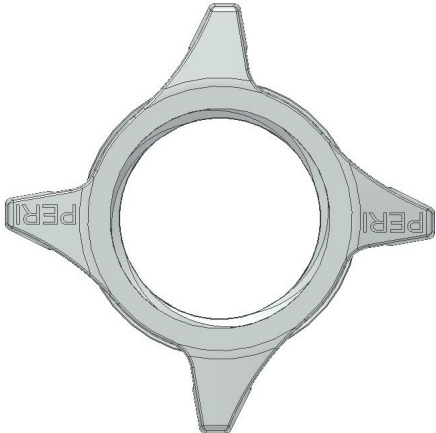
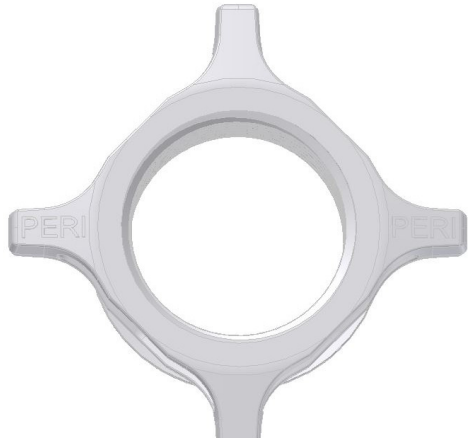
20.05.52 Cracks in collar (new Version trendsetting)

New Vesion: Trendsetting (since 2015)

Old Version until 2015

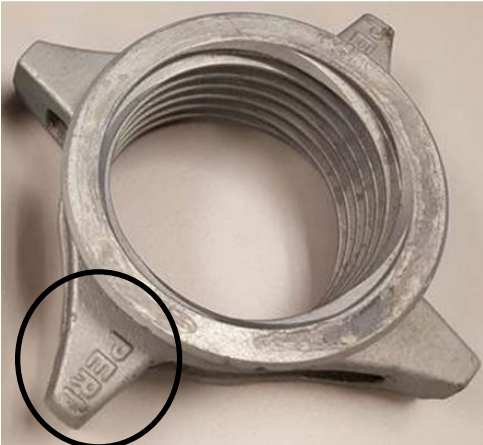
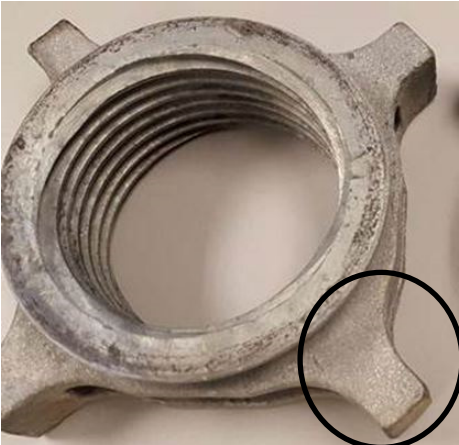
20.05.53 Copy of MULTIPROP prop

- Can be identified at the collar (PERI should be stamped in)

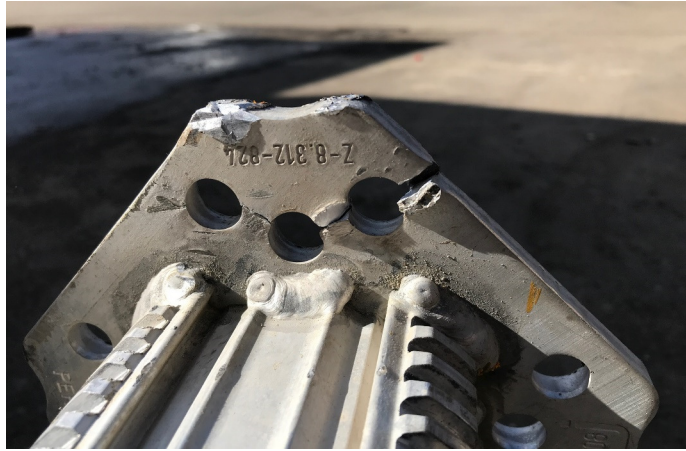
20.53.56 End plate cracked cut in	  Replace inner or outer tube

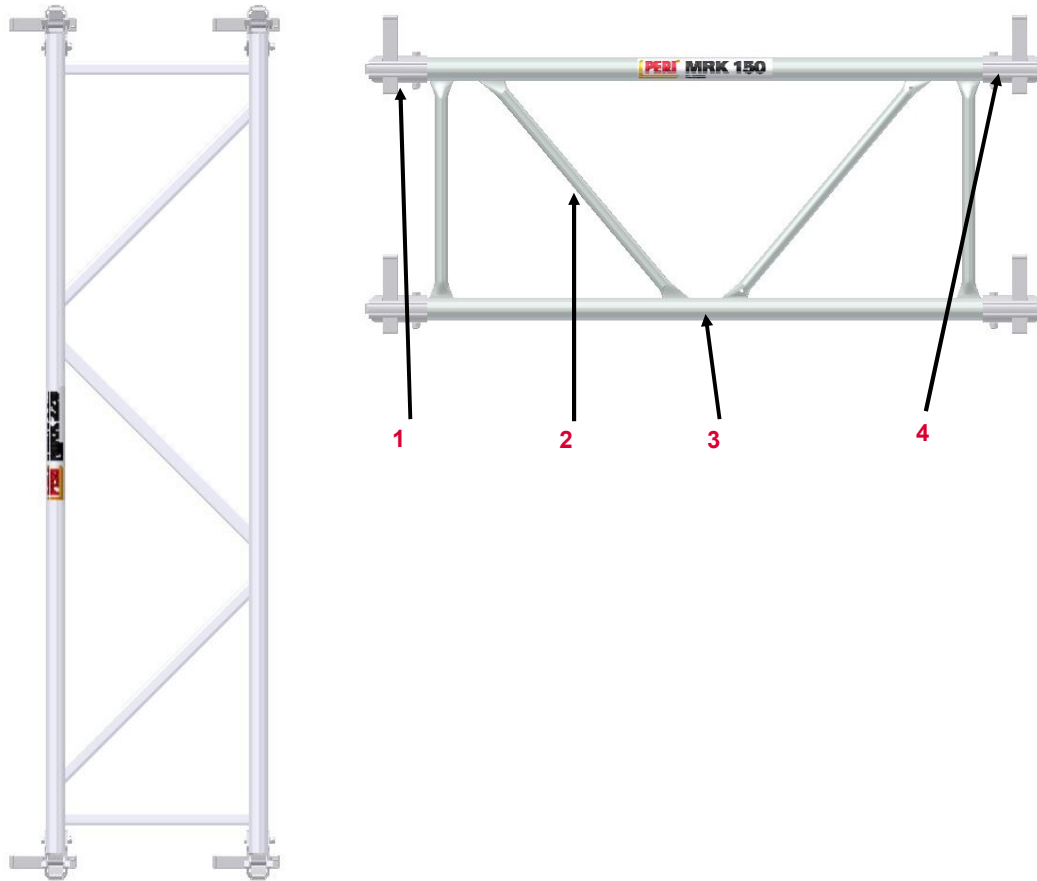
MULTIPROP Frame MRK		No.	Name	Article number
---------------------	--	-----	------	----------------

1	Connector C	105881
2	Strut	
3	Frame	
4	Connector D	105874

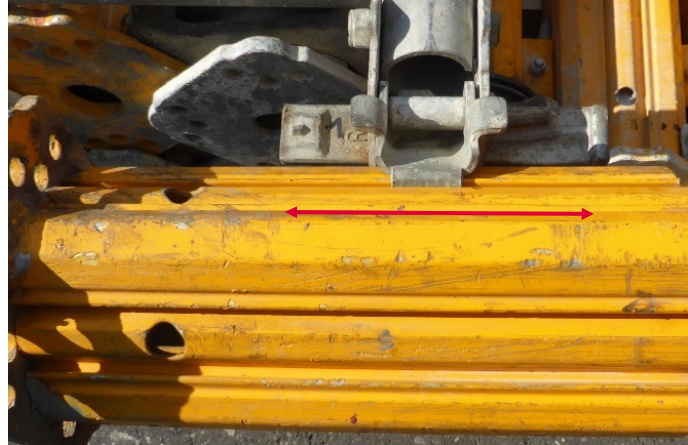
<p>20.05.12 Function of the connector not available (Prop is still moving)</p>

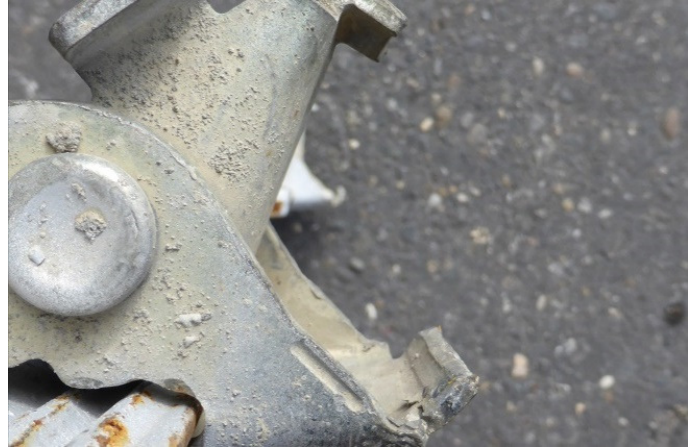
<p>20.05.13 Bent skin at the connector</p>

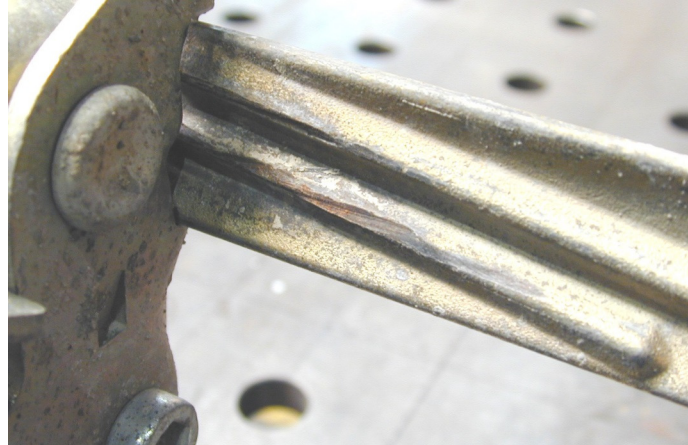
<p>20.05.15 Wedge rusty worn</p> <ul style="list-style-type: none"> ■ Function not available 	<p>105881 (Connector C) 105874 (Connector D)</p>

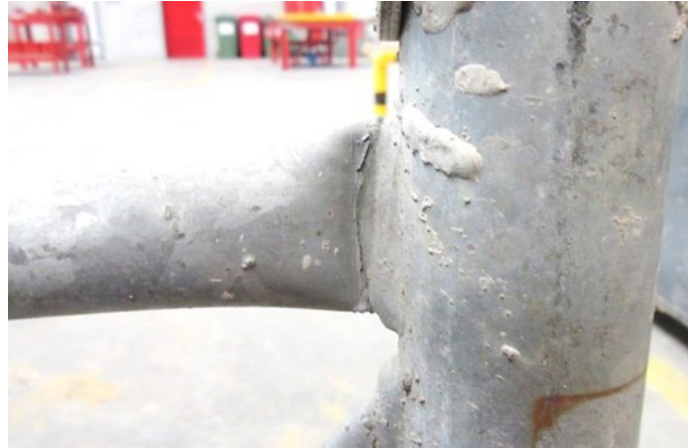
<p>20.05.16 Crack in welding</p> <ul style="list-style-type: none"> ■ Without deformation ■ Or with deformations 	<p>Without deformation:

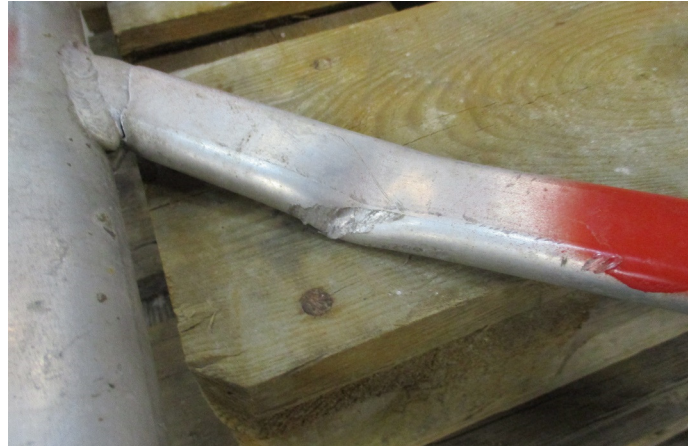
<p>20.05.54 Brace bent</p> <ul style="list-style-type: none"> ■ If possible ■ Or edges of the brace affected ■ Or kink in brace 	<ul style="list-style-type: none"> ■ If possible:

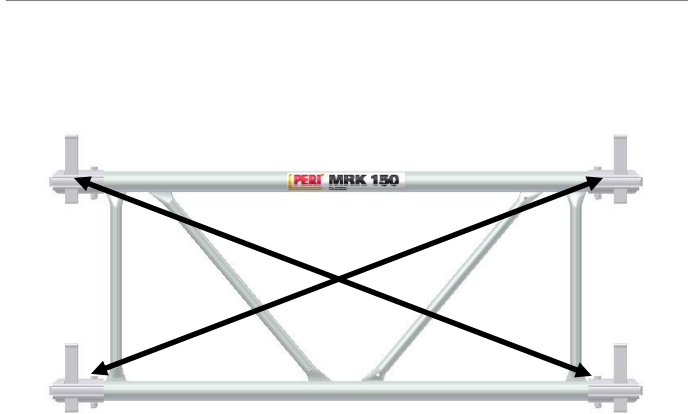
<p>20.05.55 MRK bent diagonally</p> <ul style="list-style-type: none"> ■ If possible ■ Or if not possible 	<ul style="list-style-type: none"> ■ If possible:

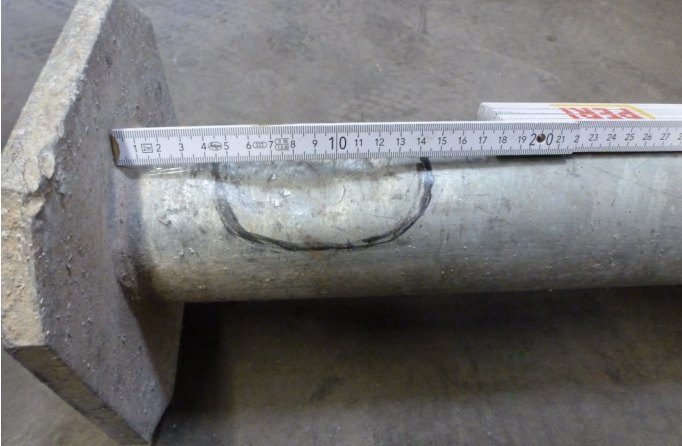
<p>20.05.17 Tube bent</p> <ul style="list-style-type: none"> ■ ≤ 6 mm depth ≤ Ø 60 mm ■ Or > 6 mm depth ■ Or > Ø 60 mm 	<ul style="list-style-type: none">

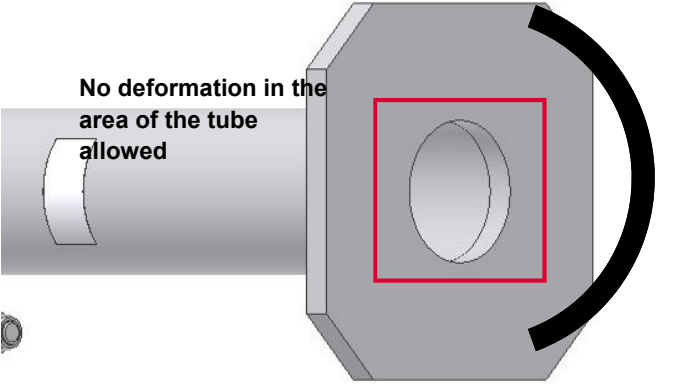
<p>No deformation in the area of the tube allowed</p>	<p>20.05.18 Head or base plate bent</p> <ul style="list-style-type: none"> ■ ≤ 15 mm ■ Or > 15 mm 	<ul style="list-style-type: none">

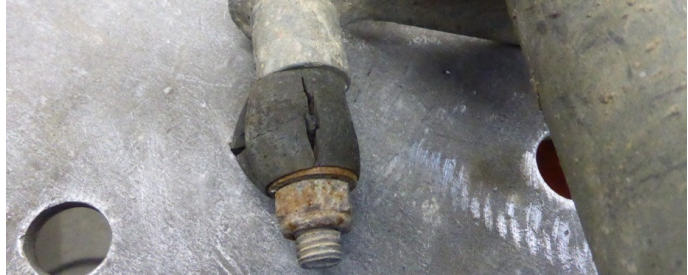
<p>20.05.19 Spring tube damaged, missing</p> <ul style="list-style-type: none"> ■ Spring tube 1st. Version (black) ■ Or spring tube 2nd. Version (orange) 	<p>

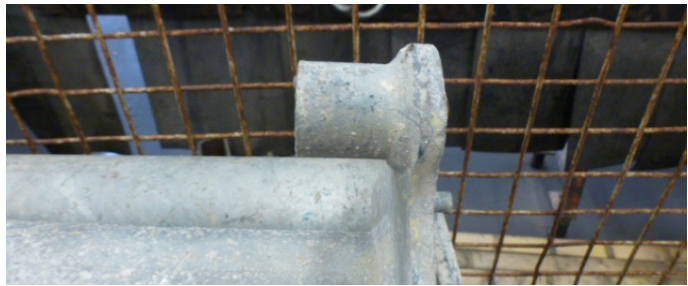
<p>20.05.20 Tension claw damaged, missing</p>	<p>

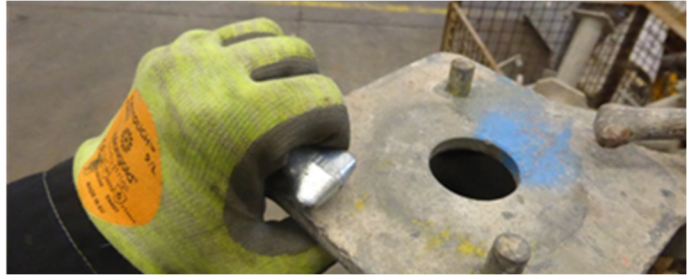
<p>20.05.21 Tension claw not tightened</p> <ul style="list-style-type: none"> ■ Tension claw should have some resistance when moved by hand 	<p>

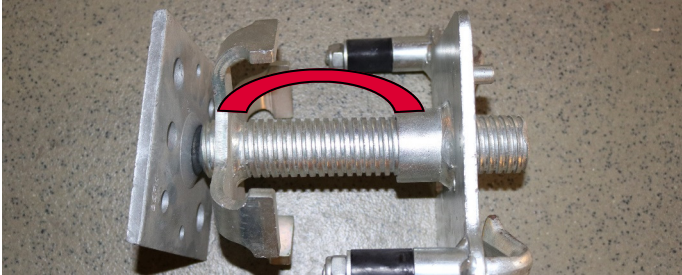
20.05.22 Spindle bent ■ > 5 mm

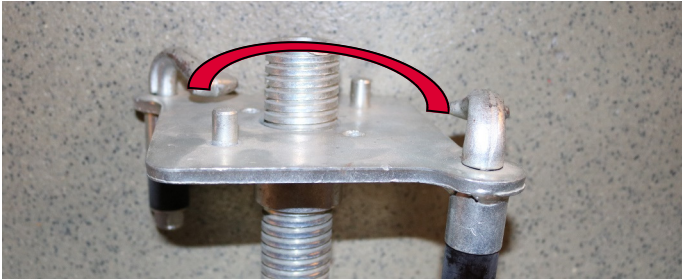
20.05.23 Head or ground plate bent ■ > 5 mm

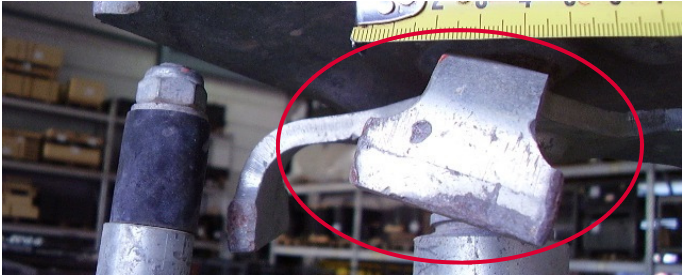
20.05.23 Rotor bent ■ Without crack in rotor ■ Or with crack in rotor	If possible

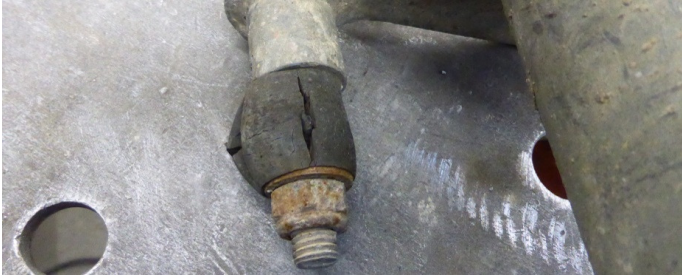
20.05.25 Spring tube damaged, missing			
	<ul style="list-style-type: none"> ■ Spring tube 1st. Version (black) ■ Or spring tube 2nd. Version (orange)

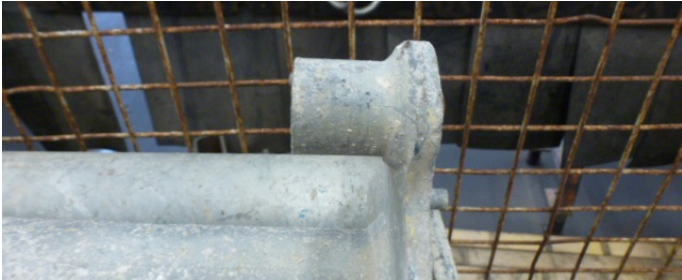
20.05.26 Tension claw damaged, missing

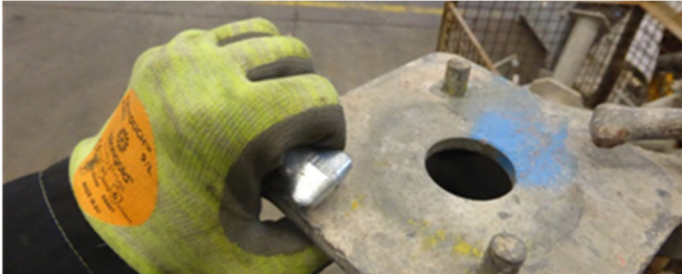
20.05.27 Tension claw not tightened	<ul style="list-style-type: none"> ■ Tension claw should have some resistance when moved by hand

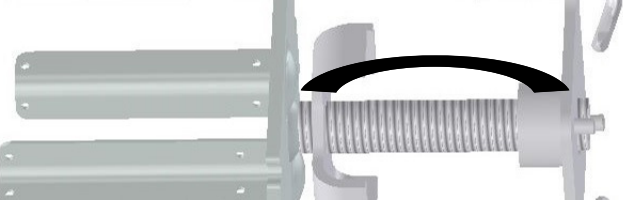
<p>20.05.28 Spindle bent</p> <ul style="list-style-type: none"> ■ > 5 mm

<p>20.05.29 Head or ground plate bent</p> <ul style="list-style-type: none"> ■ > 5 mm

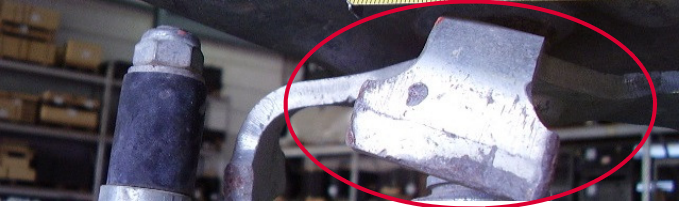
<p>20.05.30 Rotor bent</p> <ul style="list-style-type: none"> ■ Without crack in rotor ■ Or with crack in rotor 	<p>

<p>20.05.31 Plaid bent</p> <ul style="list-style-type: none"> ■ Without crack in welding ■ Or with crack in welding 	<p>

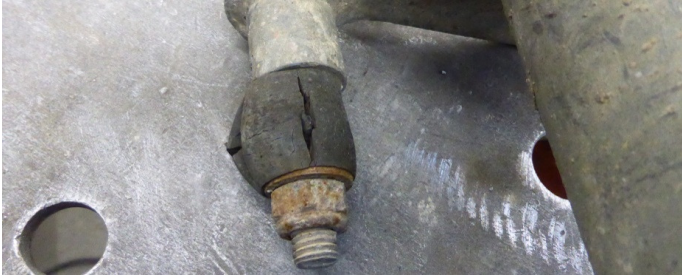
20.05.32 Spring tube damaged, missing			
	<ul style="list-style-type: none"> ■ Spring tube 1st. Version (black) ■ Or spring tube 2nd. Version (orange)

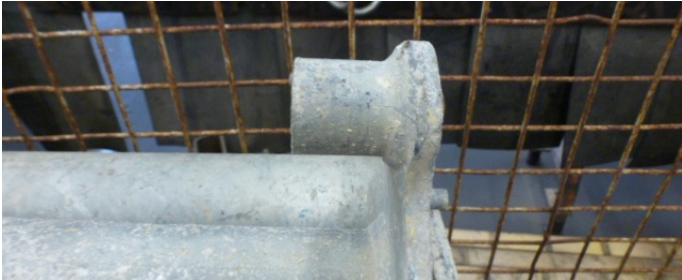
20.05.33 Tension claw damaged, missing

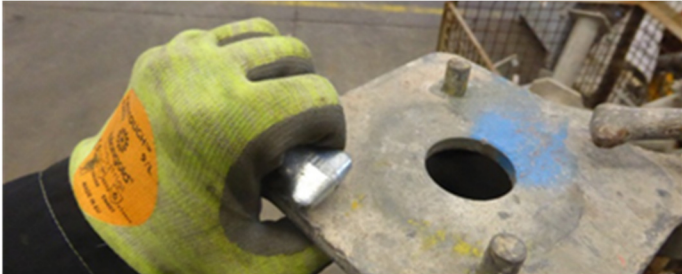
20.05.34 Tension claw not tightened	<ul style="list-style-type: none"> ■ Tension claw should have some resistance when moved by hand

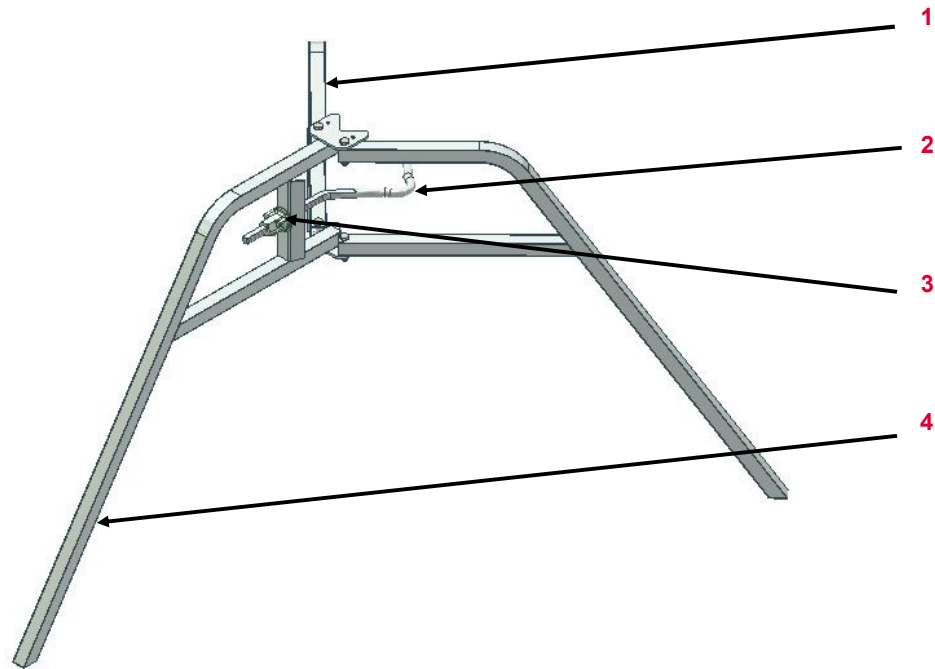
Universal tripod (028000)	No.	Name	Article number
---------------------------	-----	------	----------------

1	Pivoting leg	715643
2	Tension hoop	710161
3	Cam nut	030130
4	Support leg	715642

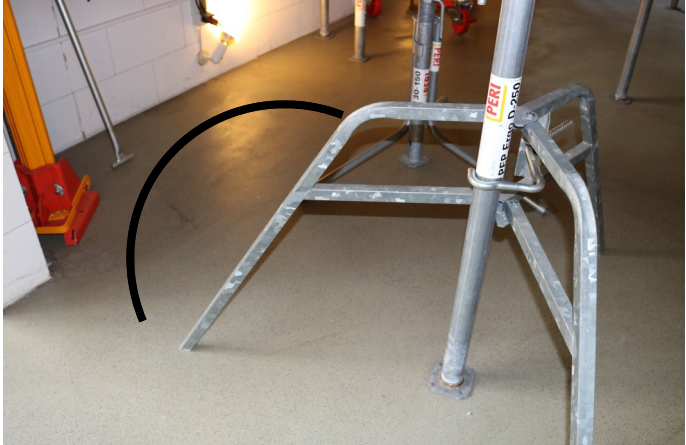
20.05.35 Pivoting arm bent

- If bending possible
- Or if not possible

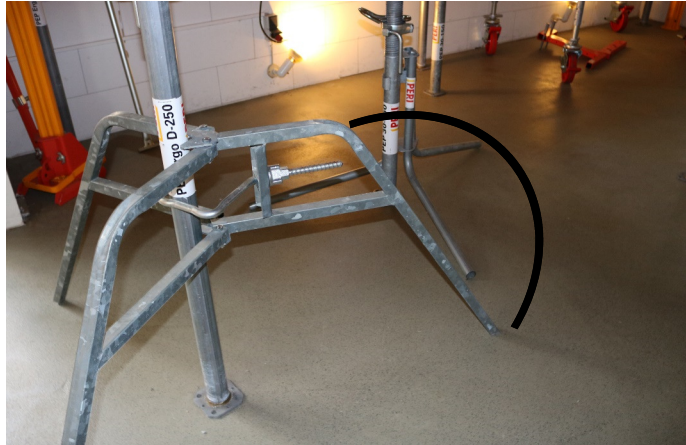
20.05.36 support leg bent

- If possible
- Or if not possible

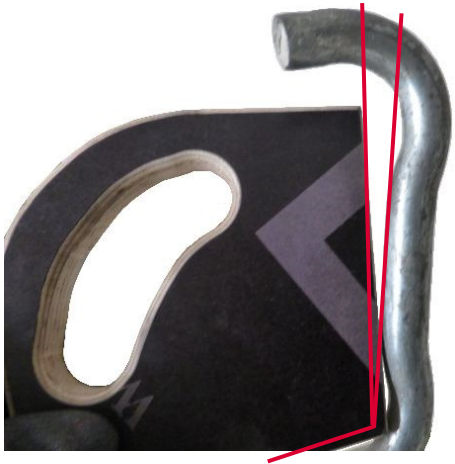
20.05.37 Tension hoop bent

- > 100°

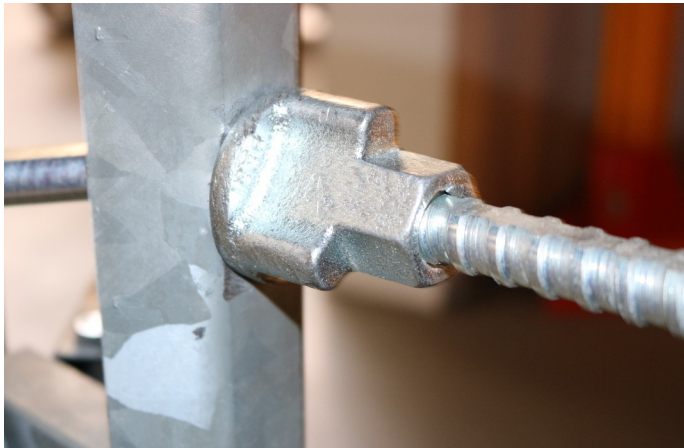
20.05.38 Nut at the cam nut broken

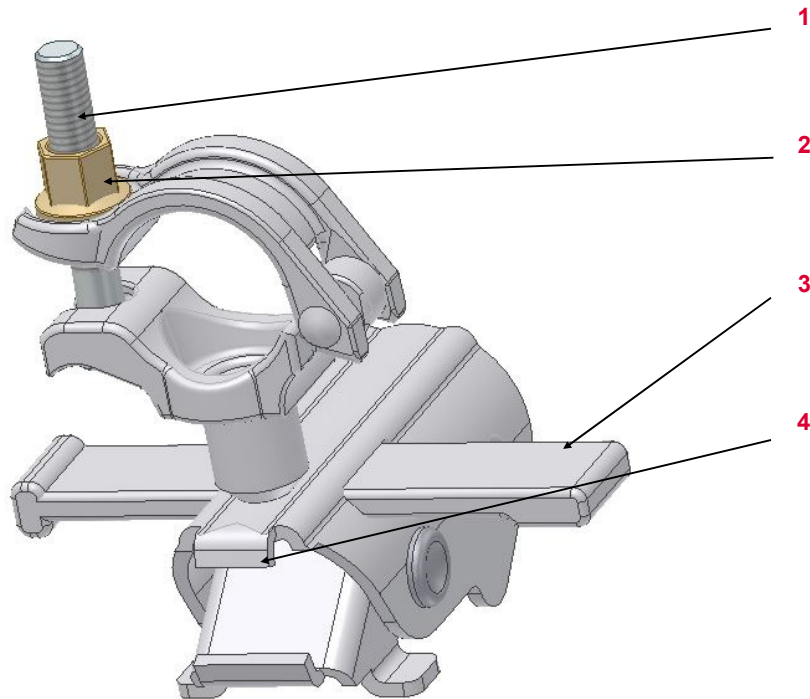
Scaffolding tube	No.	Name	Article number
------------------	-----	------	----------------

1	Hammer head bolt	710702
2	Nut	710340
3	Wedge	
4	Connector

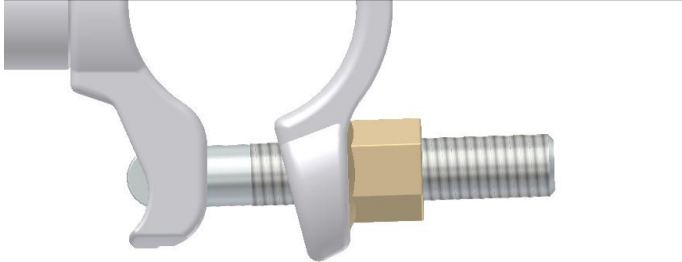
20.05.39 Hammer head bolt defect, missing

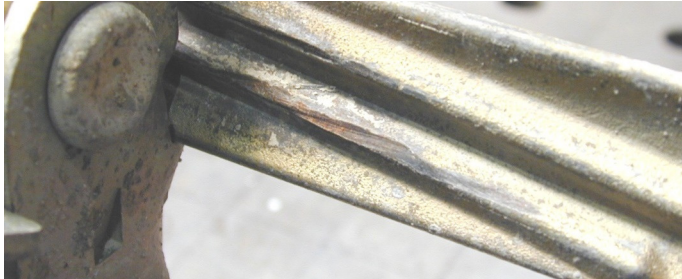
20.05.40 Function of the wedge not available

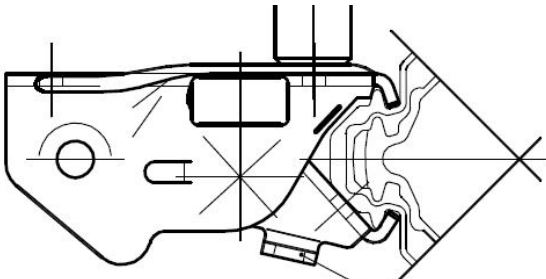
20.05.41 Connection to MULTIPTOP Prop not possible

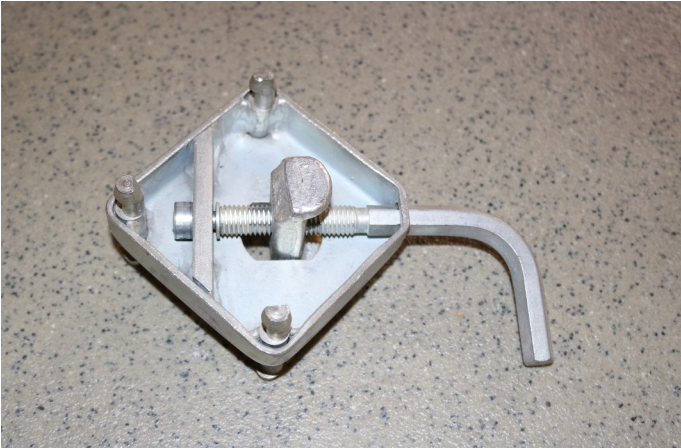
20.05.42 Bolt or spanner missing

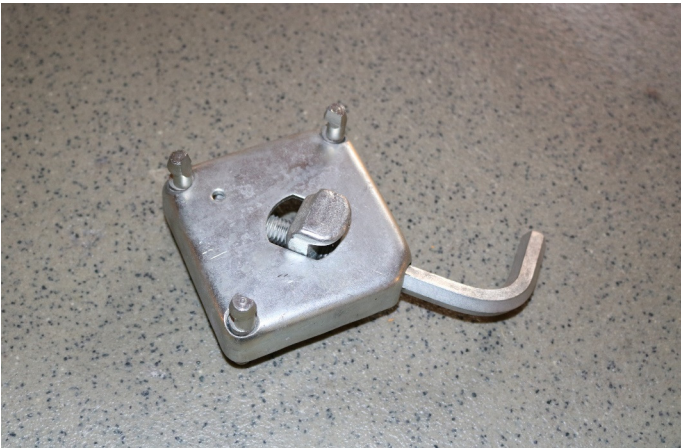
20.05.43 Bent, deformed

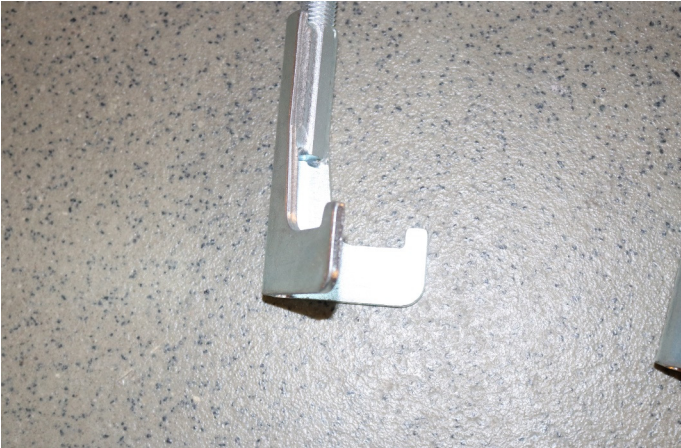
20.05.44 Bracket bent | missing

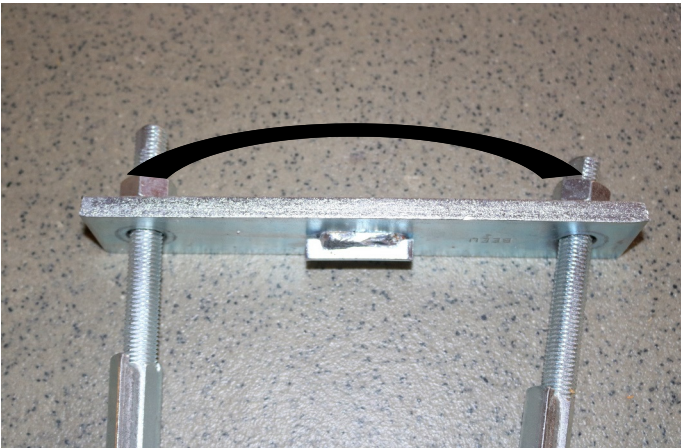
20.05.45 Yoke bent

■ > 10 mm

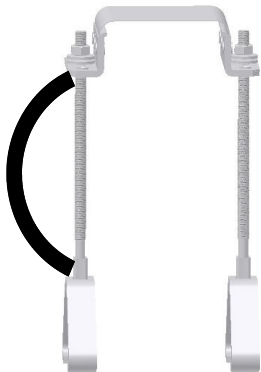
20.05.46 Thread bent

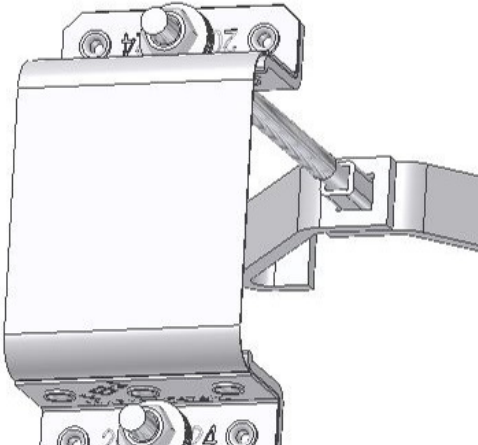
20.05.47 Plate damaged, deformed

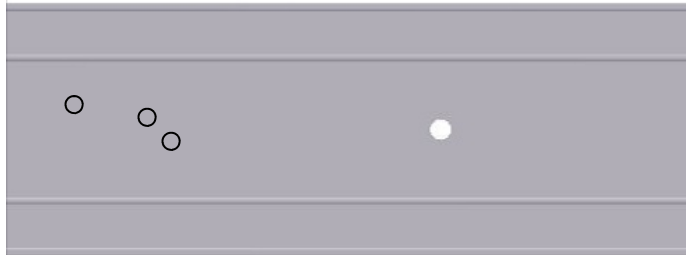
<p>20.05.48 Nail holes</p> <ul style="list-style-type: none"> ■ ≤ Ø 5 mm ■ Or > Ø 5 mm 	<ul style="list-style-type: none"> ■ ✓ ■ 🗑️ 🚫 	<ul style="list-style-type: none"> ■ 🚫 ■ 📊 	<ul style="list-style-type: none"> ■ 👁️ ■ ⚠️

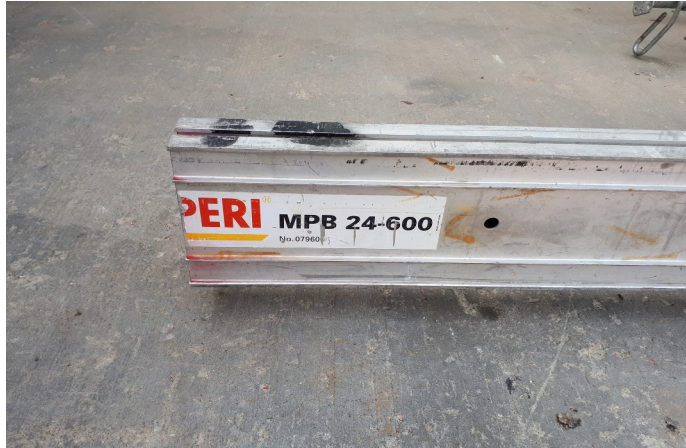
<p>20.05.49 Beam shortened</p> <ul style="list-style-type: none"> ■ Just permitted in combination with the correct drilling of the holes 	<ul style="list-style-type: none"> ■ ✓ 	<ul style="list-style-type: none"> ■ 🚫 	<ul style="list-style-type: none"> ■ 👁️

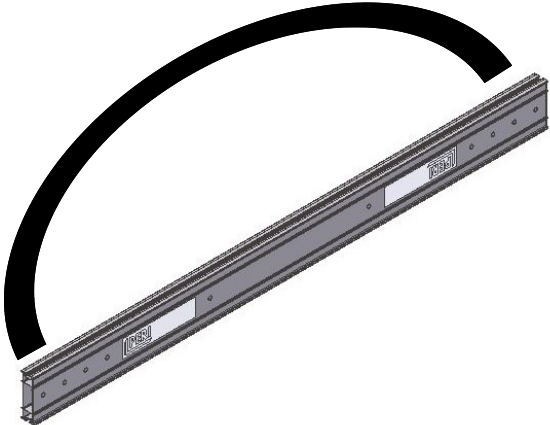
20.05.50 Beam bent

■ ≤ permitted bent

■ Or > permitted bent

Article	Perm. bent
MPB 24, L= 3,00 m	6,0 mm
MPB 24, L= 3,60 m	7,0 mm
MPB 24, L= 4,20 m	9,0 mm
MPB 24, L= 4,80 m	9,5 mm
MPB 24, L= 5,40 m	11,0 mm
MPB 24, L= 6,00 m	12,0 mm

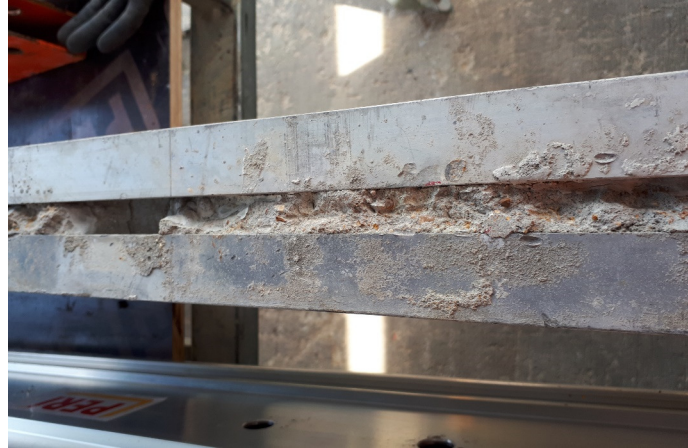
<p>20.05.57 Soiled guide profile</p> <ul style="list-style-type: none"> ■ If possible ■ Or if not possible anymore 	<p>

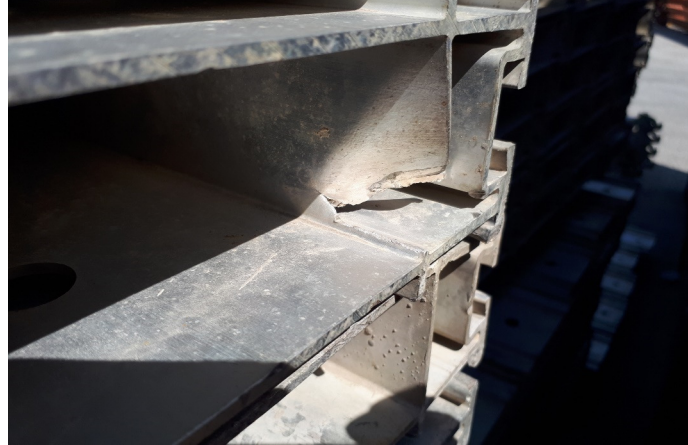
<p>20.05.58 Cracks in inner profile</p>	<p>

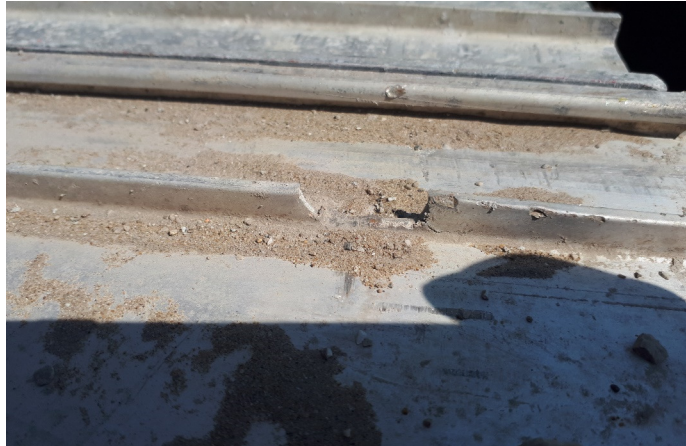
25.05.59 Crack in outer profile

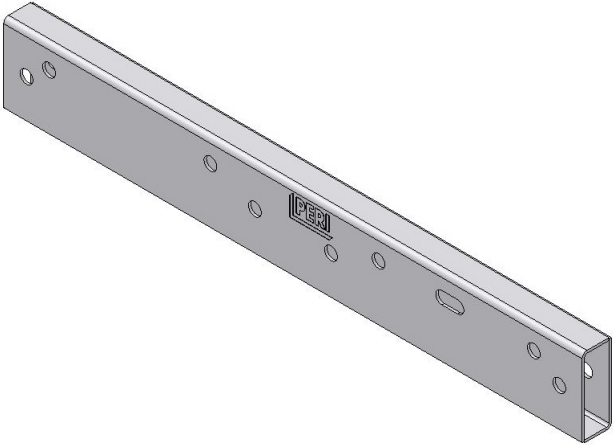
20.05.51 Splice bent
