# PERI Rental Criteria

## GT 24 Girder

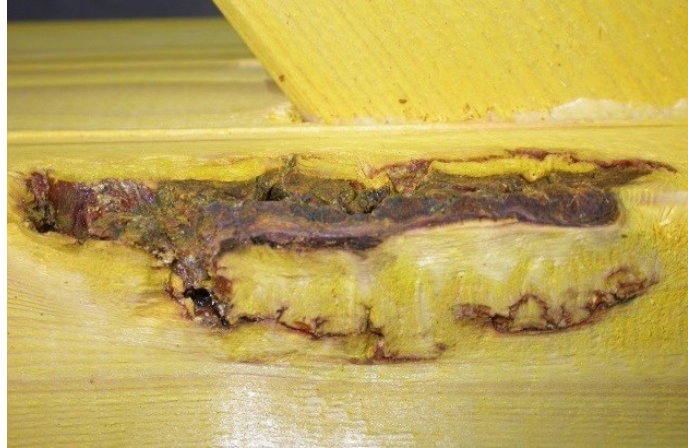
<p>01.01 Intergrowth of bark</p>

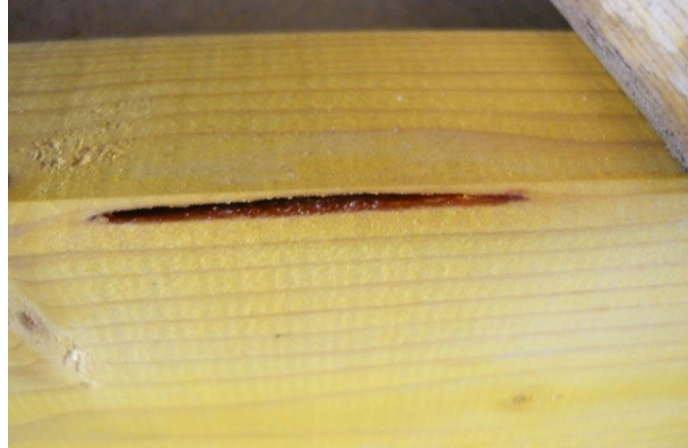
<p>01.02 Resin inclusion</p> <ul style="list-style-type: none"> <li>■ ≤ 5 mm</li> </ul>

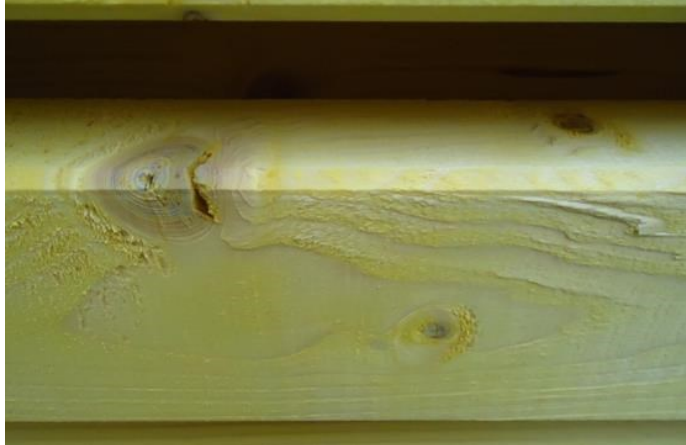
<p>01.03 Knot in the girder edge</p>

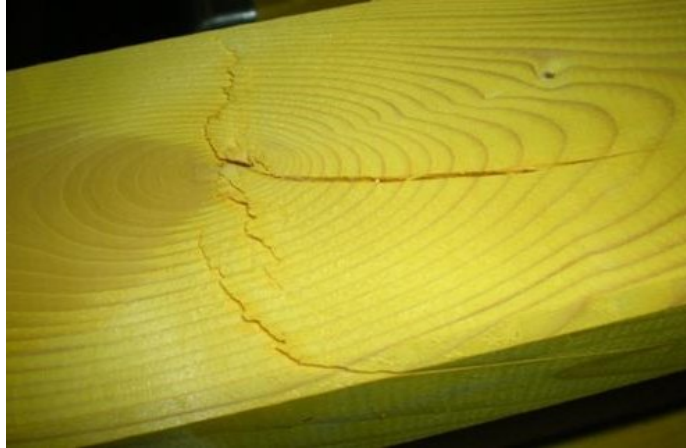
<p>01.04 Round break</p>

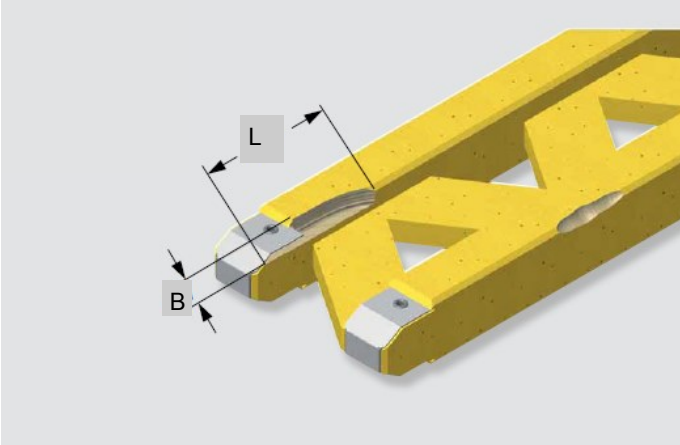
<b>01.05 Splintering at the chord</b> <ul style="list-style-type: none"> <li>■ <math>\leq 33</math> mm width</li> <li>■ and <math>\leq 35</math> cm length</li> </ul>

<ul style="list-style-type: none"> <li>■ Or <math>&gt; 35</math> cm length</li> <li>■ and <math>\leq 10</math> mm width</li> </ul>

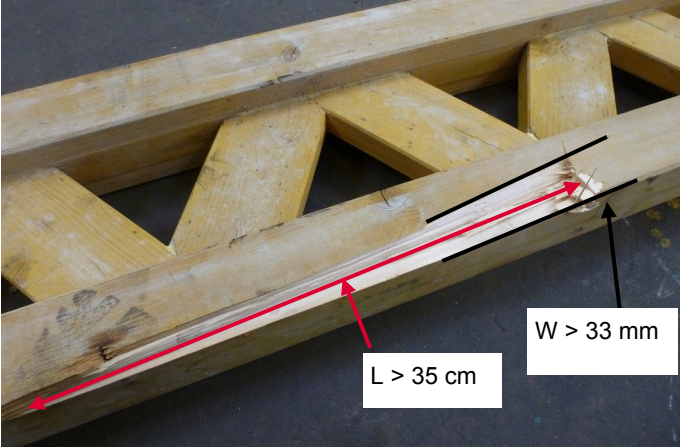
<b>01.06 Splintering at the chord</b> <ul style="list-style-type: none"> <li>■ <math>&gt; 33</math> mm width</li> </ul>

<ul style="list-style-type: none"> <li>■ Or <math>&gt; 35</math> cm Length</li> <li>■ and <math>&gt; 10</math> mm width</li> </ul>

See table (p. 18)

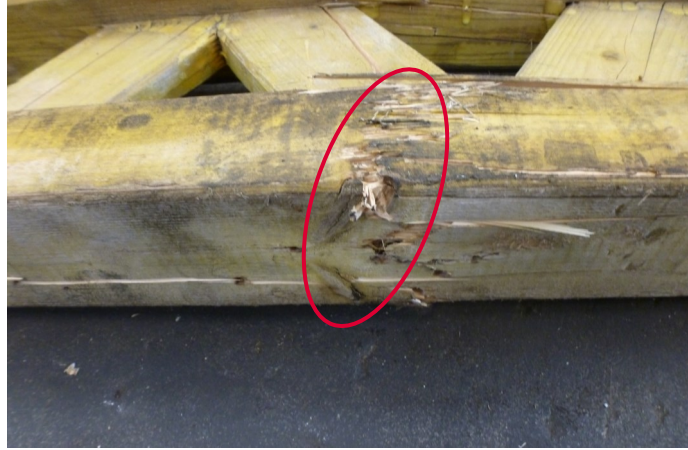
<p><b>01.07 Break of the chord</b></p> <ul style="list-style-type: none"> <li>■ Break caused by overloading</li> </ul>

See table (p. 18)

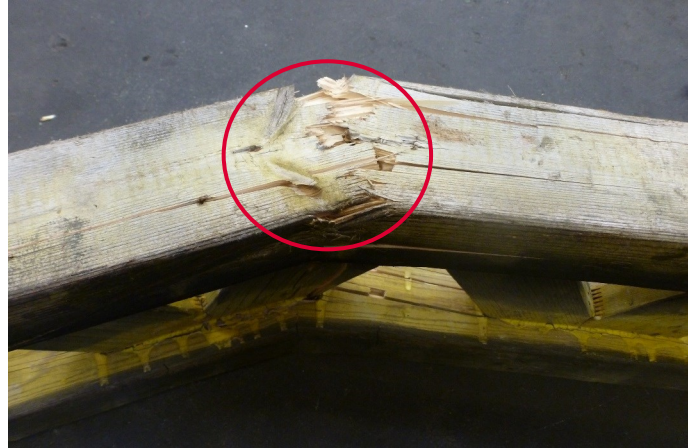
<p><b>01.08 Break across the grain</b></p>

See table (p. 18)

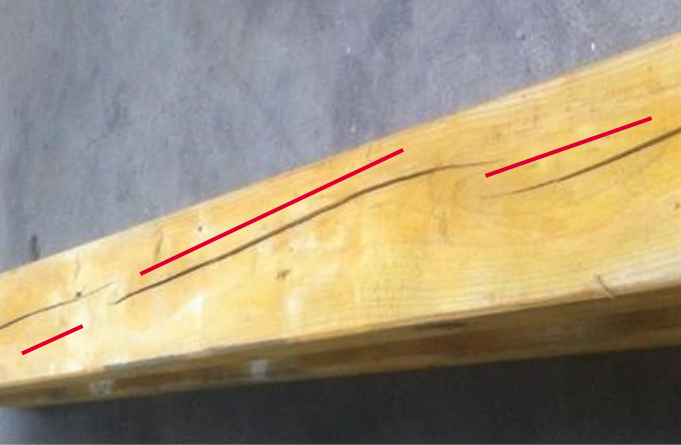
<p><b>01.09 Shrinkage caused by drying out</b></p> <ul style="list-style-type: none"> <li>■ Crack along the grain</li> <li>■ and no continuous crack</li> <li>■ and max. width <math>\leq 4</math> mm</li> <li>■ and max. length 1 m</li> </ul>

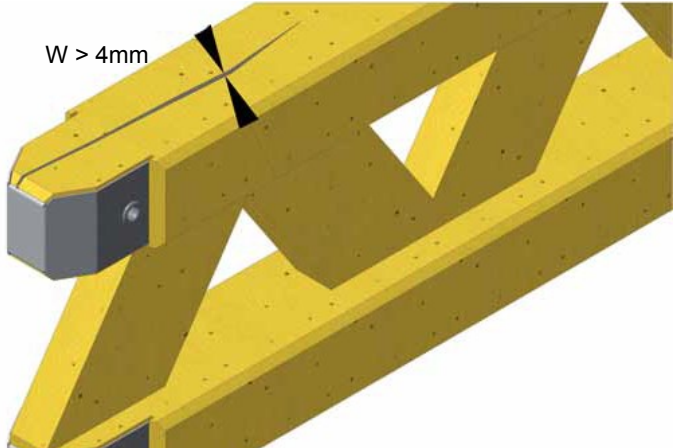
<p><b>01.10 Shrinkage crack</b></p> <ul style="list-style-type: none"> <li>■ Width <math>&gt; 4</math> mm</li> <li>■ Length <math>&gt; 1</math> m</li> </ul>

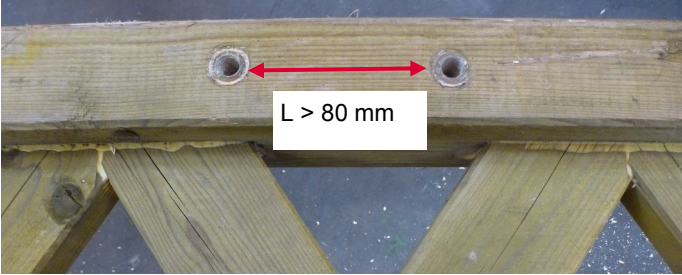
<p><b>01.15 Holes M6/M8 in Chord</b></p> <ul style="list-style-type: none"> <li>Max. 2 holes axial (in one line)</li> <li>and minimum distance 80 mm</li> <li>and distance to next drill hole &gt; next knot pattern</li> </ul>

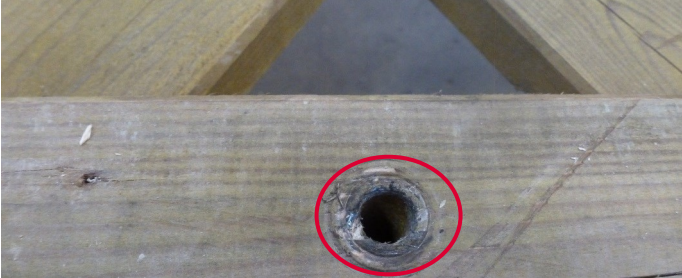
<p><b>01.16 Holes <math>\varnothing \leq 12</math> mm in Chord</b></p> <ul style="list-style-type: none"> <li>Max. 1 hole between knot pattern</li> </ul>

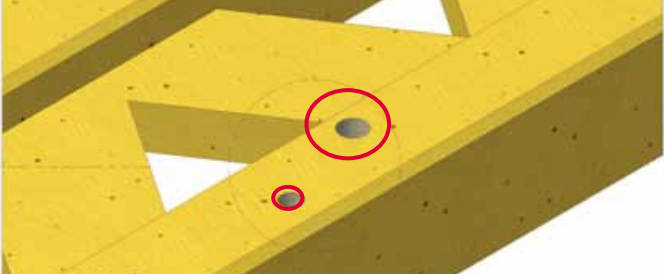
<p><b>01.17 Holes <math>\varnothing \leq 12</math> mm in Chord</b></p> <ul style="list-style-type: none"> <li>more than 1 hole between knot pattern</li> <li>Or <math>\varnothing &gt; 12</math> mm</li> </ul>

see table (p. 18)

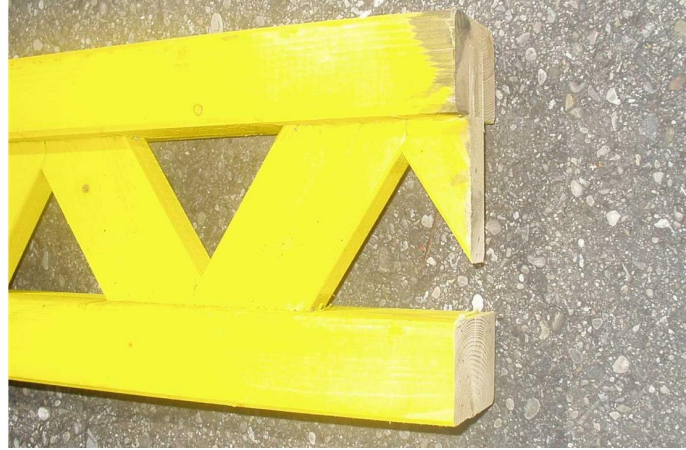
<p><b>01.21 Girder cut not according to PERI standard</b></p>

see table (p. 18)

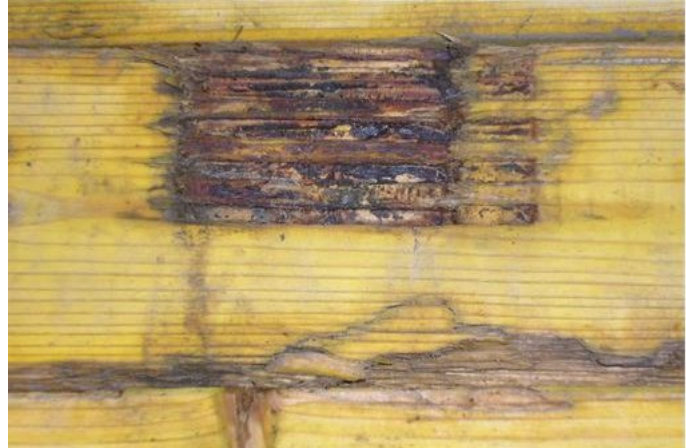
<p><b>01.22 Chord damaged by concrete vibrator</b></p> <ul style="list-style-type: none"> <li>■ Pressure marks <math>\leq 3,0</math> mm</li> <li>■ Or pressure marks <math>&gt; 3,0</math> mm</li> </ul>	<ul style="list-style-type: none"> <li>

see table (p. 18)         </li> </ul>	<ul style="list-style-type: none"> <li>

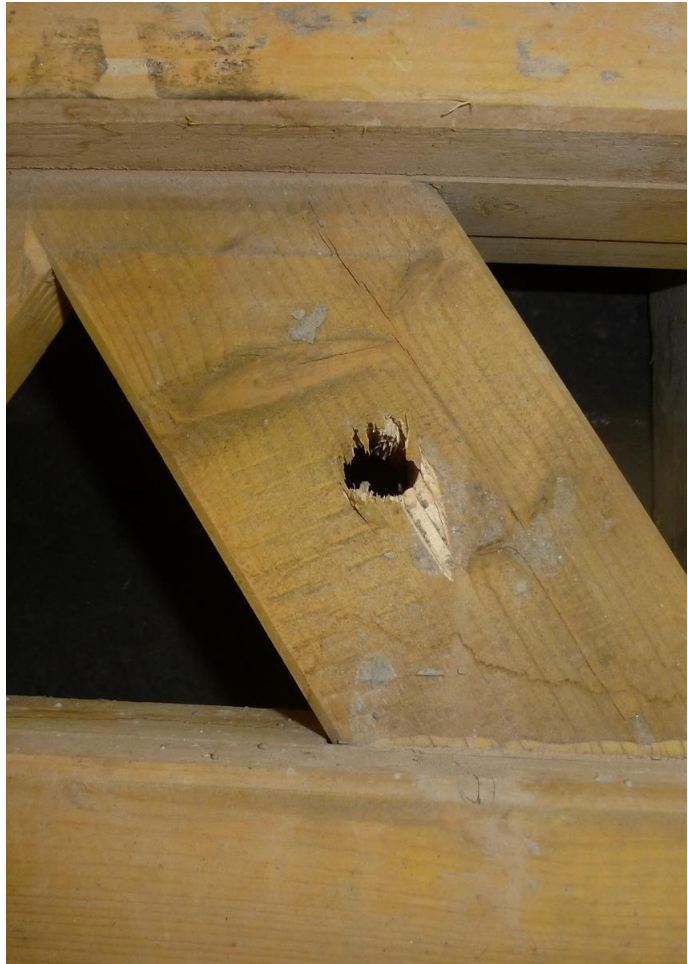
<p><b>01.23 Drill hole in brace</b></p> <ul style="list-style-type: none"> <li>■ ≤ Ø 18 mm</li> <li>■ and max. one hole in brace</li> </ul>

<ul style="list-style-type: none"> <li>■ Hole ≤ Ø 18 mm</li> <li>■ and more than one hole in brace</li> </ul>

<ul style="list-style-type: none"> <li>■ Or &gt; Ø 18mm</li> </ul>

<p>see table (p. 18)</p>

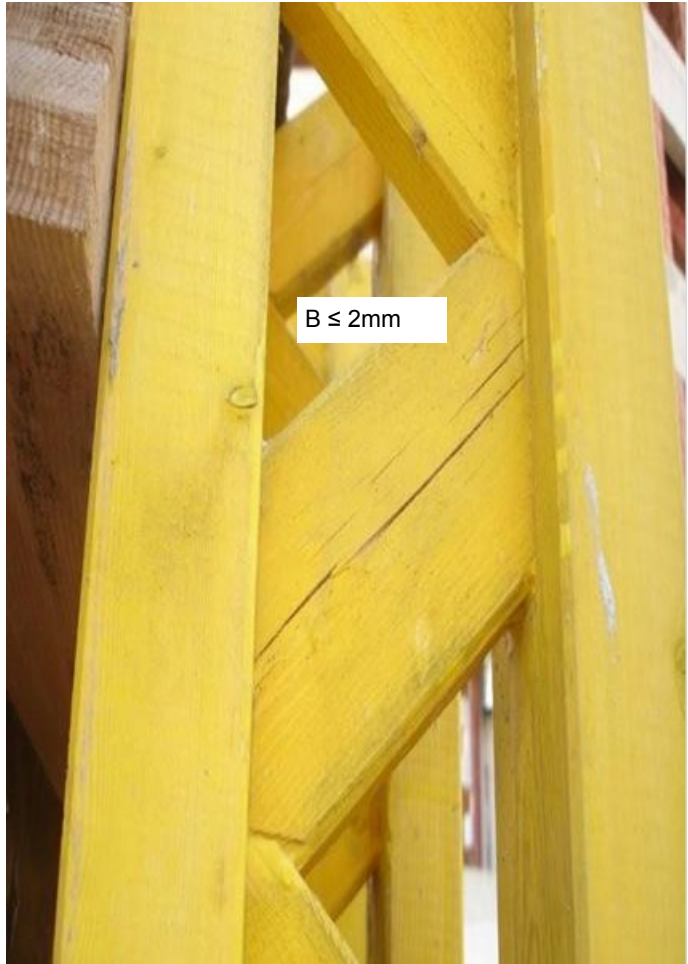
<b>01.25 Crack in brace</b>			
	<ul style="list-style-type: none"> <li>■ crack vertical to grain</li> </ul>

<ul style="list-style-type: none"> <li>■ Or crack along the grain <math>\leq 2</math> mm</li> </ul>

see table (p. 18)

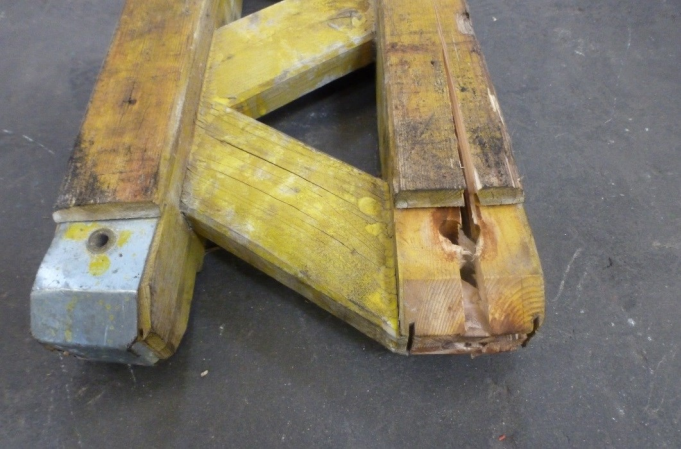
<b>01.26 Cap end broken</b>			
	<ul style="list-style-type: none"> <li>with new cap (rivet through wood)</li> </ul>

<ul style="list-style-type: none"> <li>Or with old cap</li> </ul>

<ul style="list-style-type: none"> <li>Or with old cap</li> <li>and splintering &gt; 33 mm</li> </ul>

see table (p. 18)
