PERI Rental Criteria

Industrial Scaffolding

Console UCM | Support UC

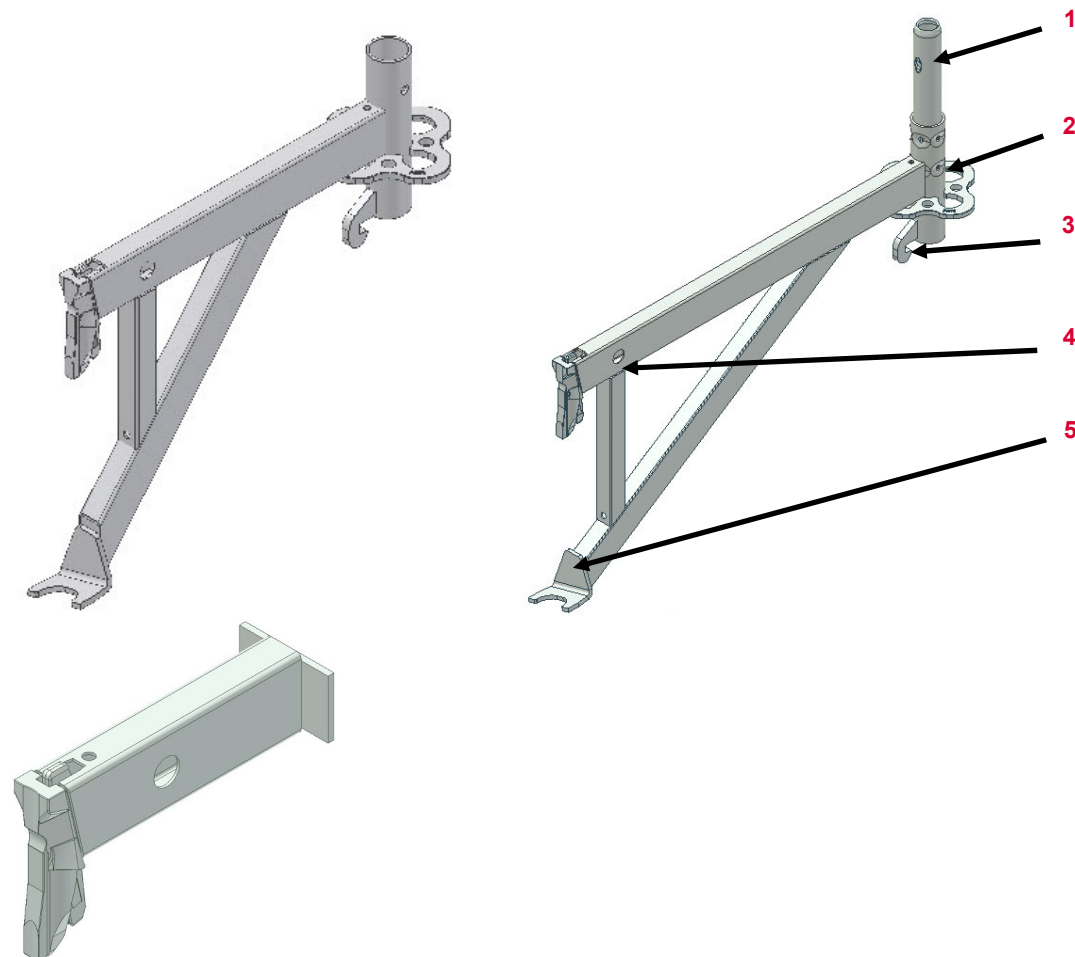
Nr.	Description	Article number
1	Spigot	
2	Rosett	
3	Bearing Protection	
4	Wedge UCM	
5	Plate UCM

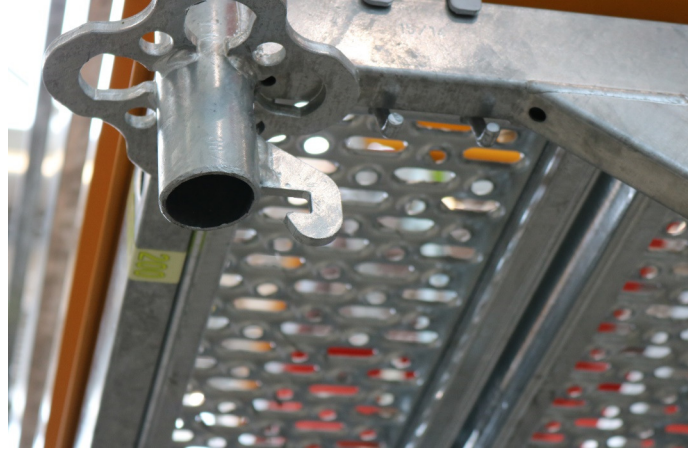
33.40.01 Bearing protection bent	<ul style="list-style-type: none"> ■ If possible

<ul style="list-style-type: none"> ■ Or if no longer possible

<ul style="list-style-type: none"> ■ Or cracks in welding

088244

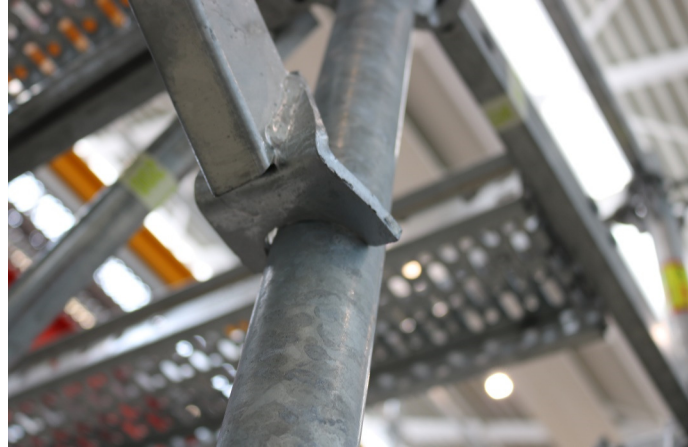
33.40.02 Plate UCM bent	<ul style="list-style-type: none"> ■ If possible (connection possible)

<ul style="list-style-type: none"> ■ Or if no longer possible

<ul style="list-style-type: none"> ■ Or cracks in welding

088244

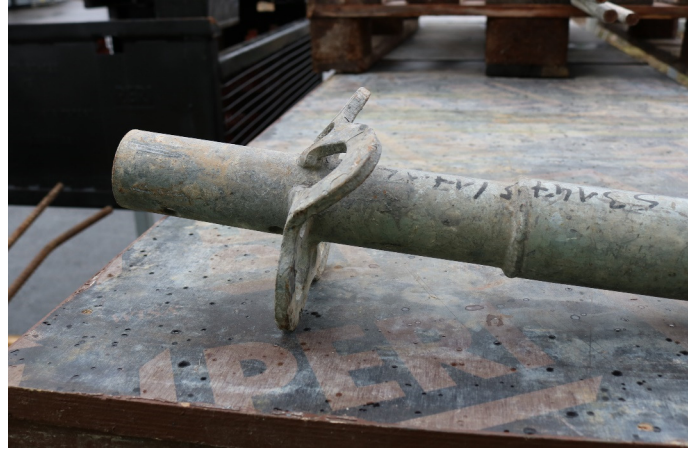
<p>33.40.03 Rosett Half-rosett bent</p> <ul style="list-style-type: none"> ■ ≤ 20 mm ■ Or > 20 mm 	<ul style="list-style-type: none">

088244

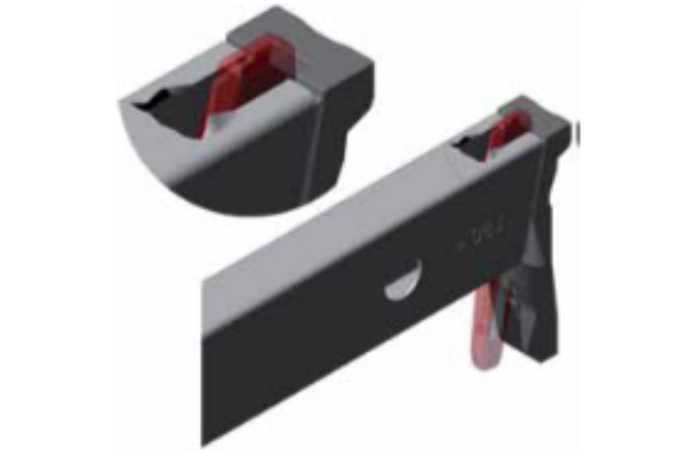
<p>33.40.04 Wedge opening torn out wedge missing</p>

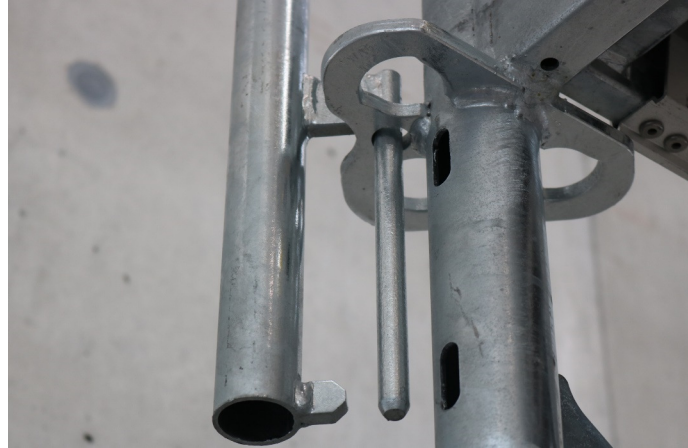
<p>33.40.07 Spigot bent</p> <ul style="list-style-type: none"> ■ If possible (Spigot insertion possible) ■ Or if no longer possible ■ Or cracks in material or welding 	<ul style="list-style-type: none">

088244

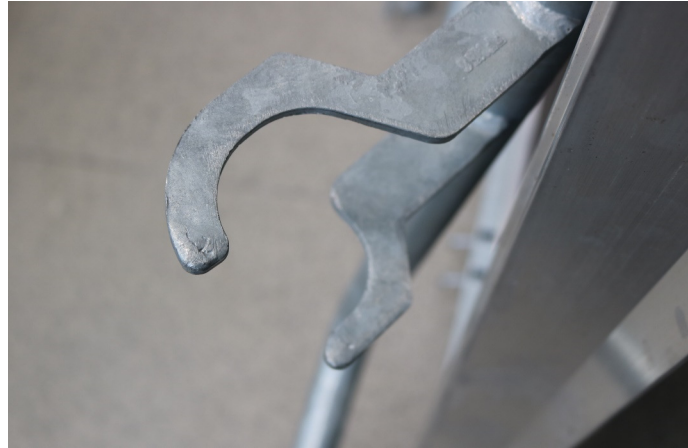
<p>33.40.08 Fork bent</p> <ul style="list-style-type: none"> ■ If possible (Connection of guardrail possible afterwards) ■ Or if not possible 	<ul style="list-style-type: none">

088244

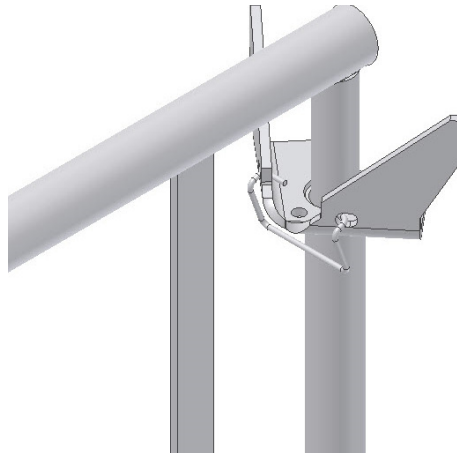
<p>33.40.09 Bearing bent unusable</p>	<p>

110565 (Bearing)</p>

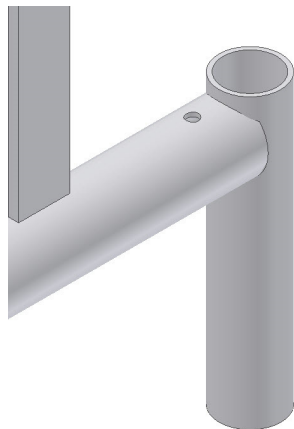
<p>33.40.10 Tube bent</p> <ul style="list-style-type: none"> ■ Guardrail can't be inserted 	<p>

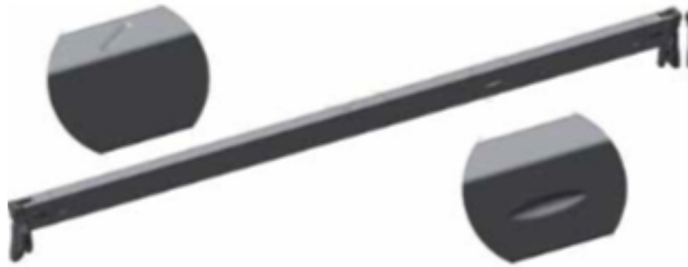
33.40.11 Local dent in profile

- Edges not affected

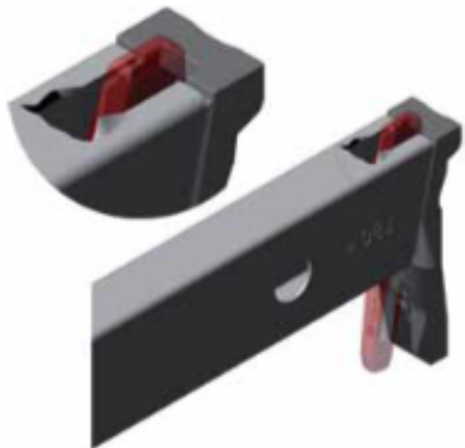
33.40.12 Wedge-opening torn out | wedge missing

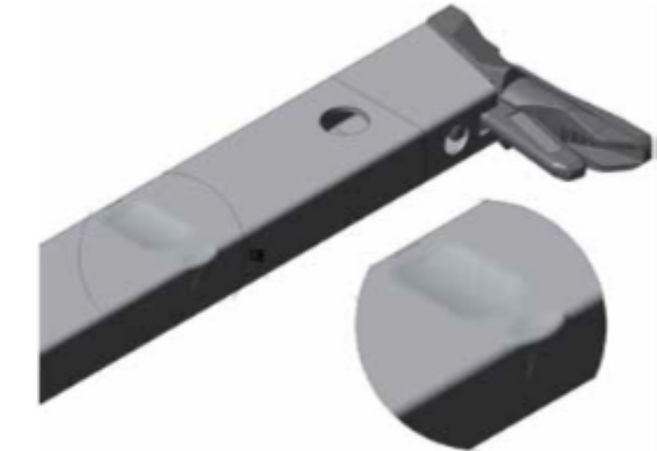
33.40.13 Profile bent at edge

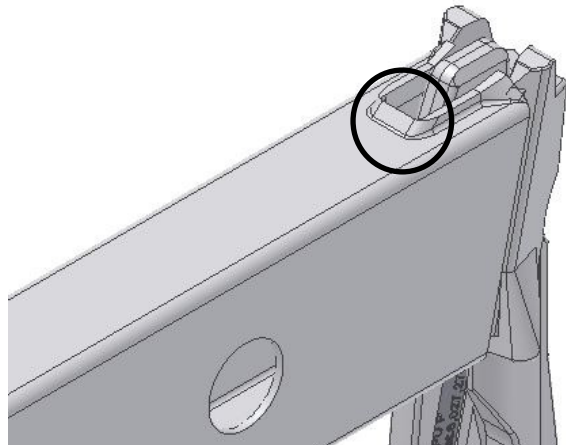
33.40.14 Dent at hook

- If possible
- Or if no longer possible
- Or crack in material

088244

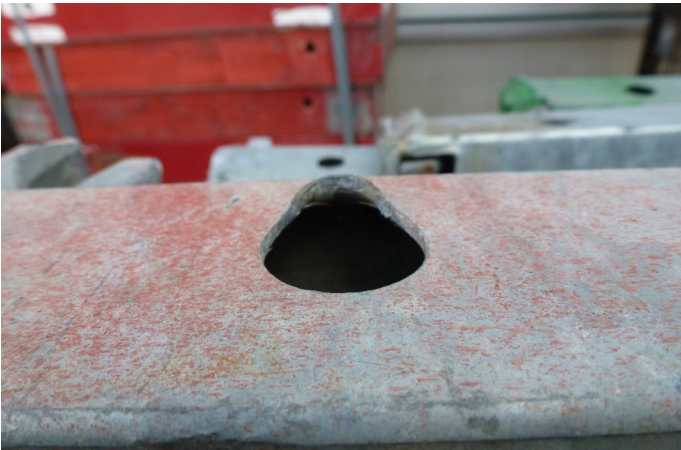
33.40.15 Hole dented

- If original geometry of hole unchanged
- Or if changed
- Or cracks in material

088244

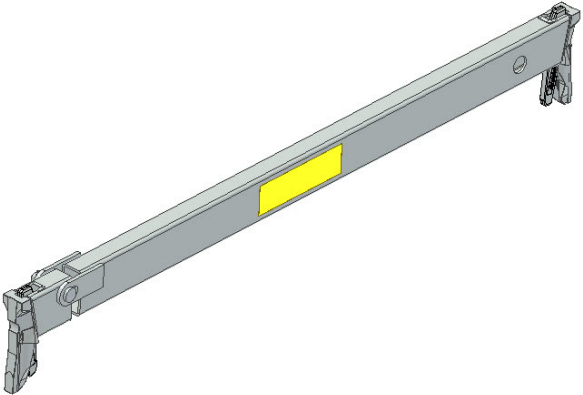
33.40.16 Bent Ledger

- Visible Deformation

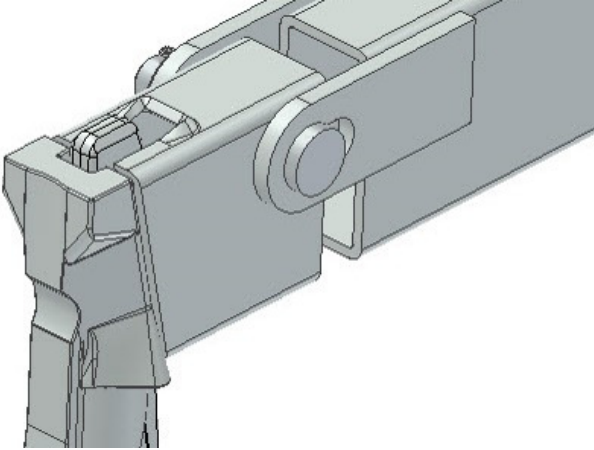
33.40.17 Wedge connector	<ul style="list-style-type: none"> <li data-bbox="1305 555 1787 627">

<ul style="list-style-type: none"> <li data-bbox="869 707 1294 735"> ■ Damaged due to violence 	<ul style="list-style-type: none"> <li data-bbox="1305 707 1787 778">

110075 (Wedge connector)

110075 (Wedge Connector)

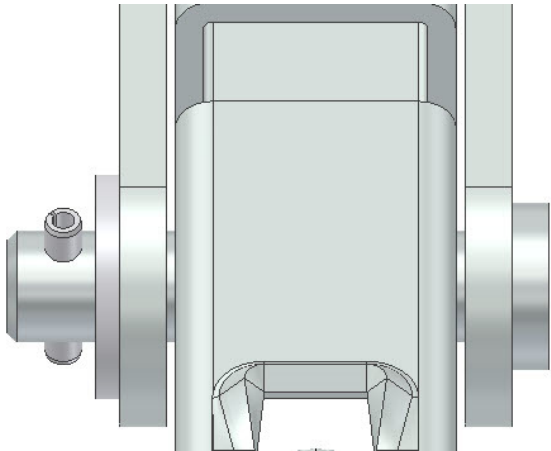
33.40.18 Bolt Dowel pin washer missing	<ul style="list-style-type: none"> <li data-bbox="1305 991 1787 1086">

117451 (Bolt) <li data-bbox="1305 1023 1787 1062">

722930 (Dowel pin) <li data-bbox="1305 1054 1787 1086">

780702 (Washer)

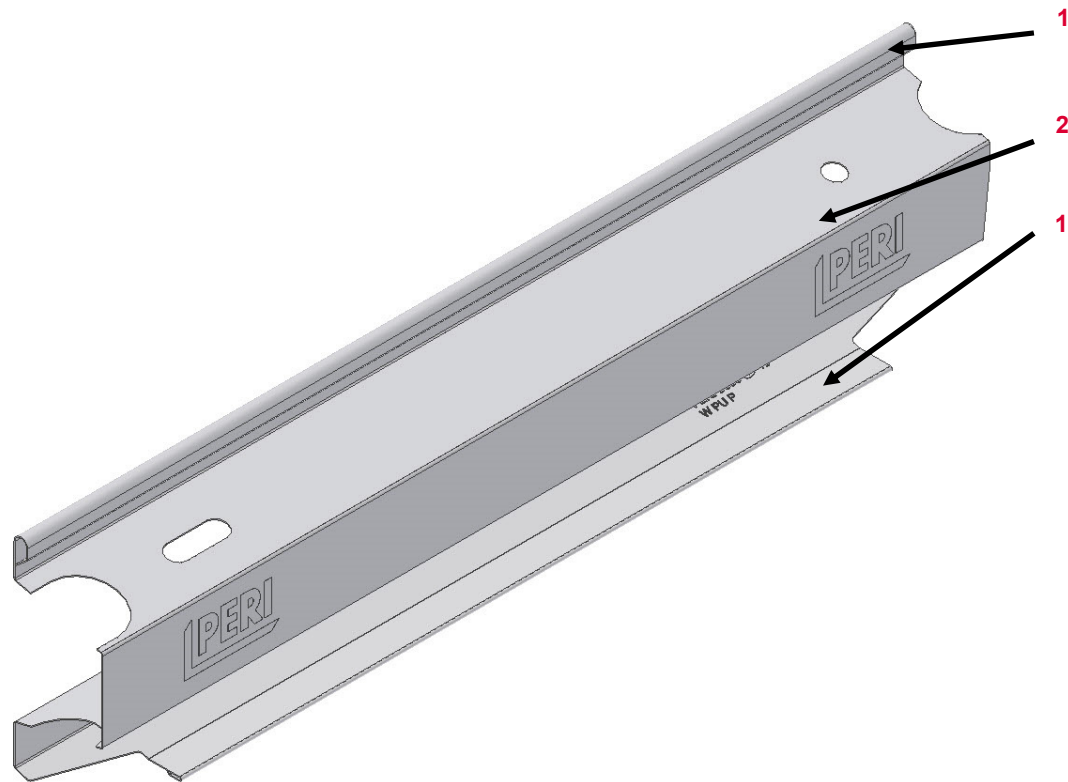
Toeboard Steel UPY	Nr.	Description	Article number
--------------------	-----	-------------	----------------

1 Edges

2 Toeboard

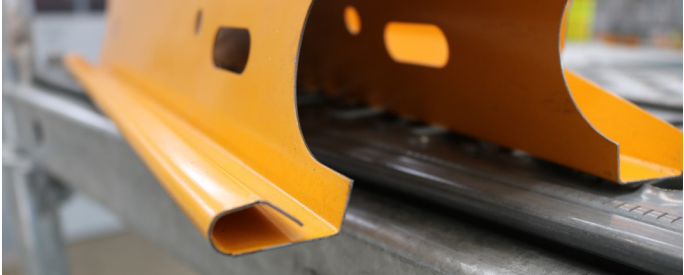
33.40.19 Edges bent	<ul style="list-style-type: none"> ■ If possible

<ul style="list-style-type: none"> ■ If no longer possible

088244

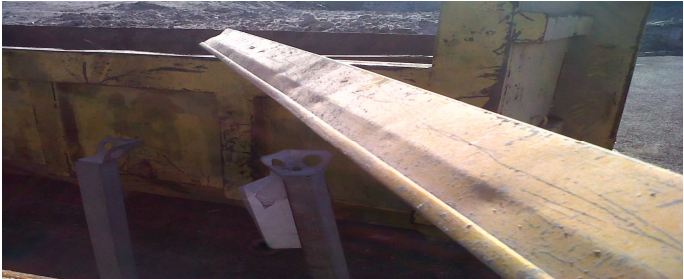
33.40.20 Toeboard bent over whole length	<ul style="list-style-type: none"> ■ If still possible and Bent $\leq L/100$

<ul style="list-style-type: none"> ■ If no longer possible ■ Or bent $> L/100$

088244

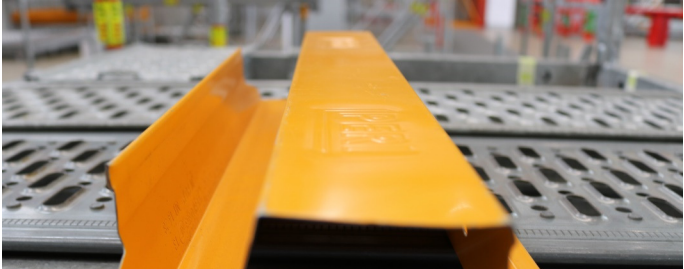
33.40.21 Dents in toeboard

088244

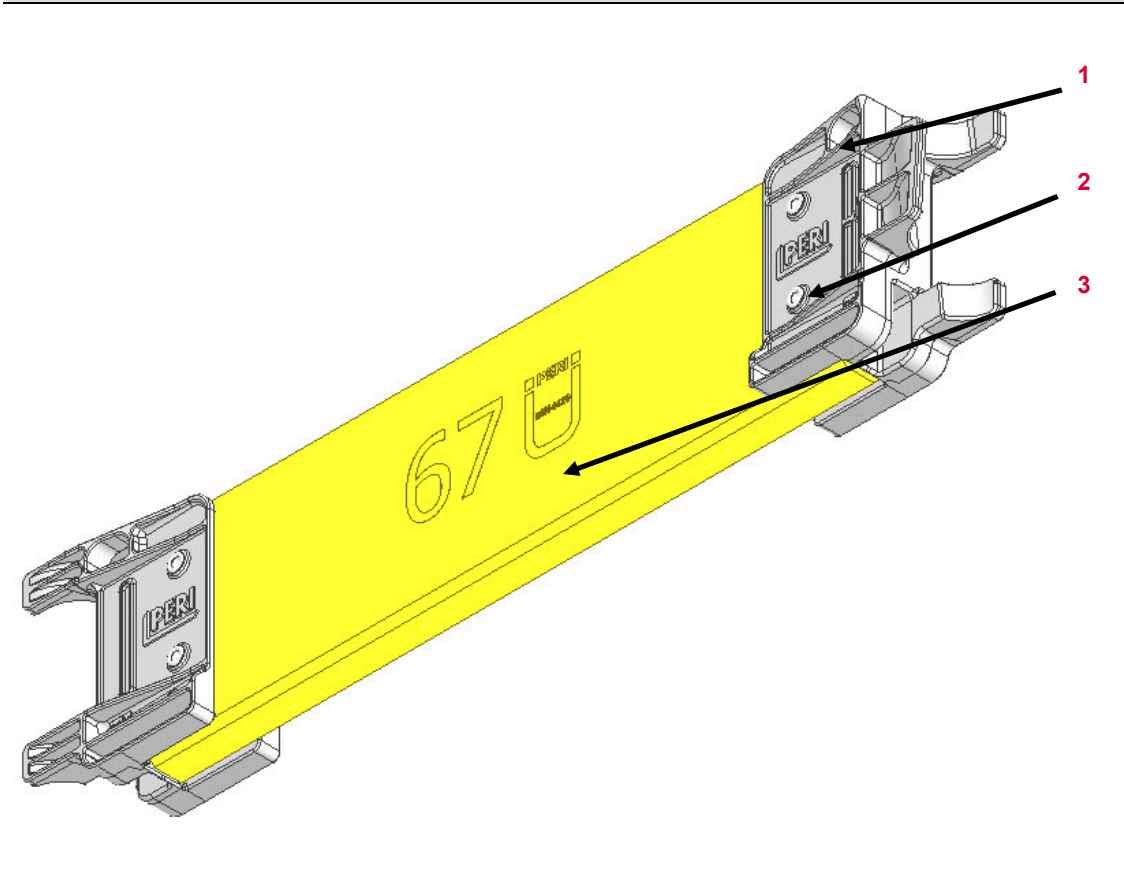
Toeboard Wood UPF	Nr.	Description	Article number

1	Toeboard hinge	
	2	Rivet	
	3	Toeboard	
	Valid for		Item number
	Toeboard Wood UPF 50		129490
	Toeboard Wood UPF 67		129492
	Toeboard Wood UPF 75		129494
	Toeboard Wood UPF 100		129496
	Toeboard Wood UPF 150		129498
	Toeboard Wood UPF 200		129500
	Toeboard Wood UPF 250		129502
	Toeboard Wood UPF 300		129504

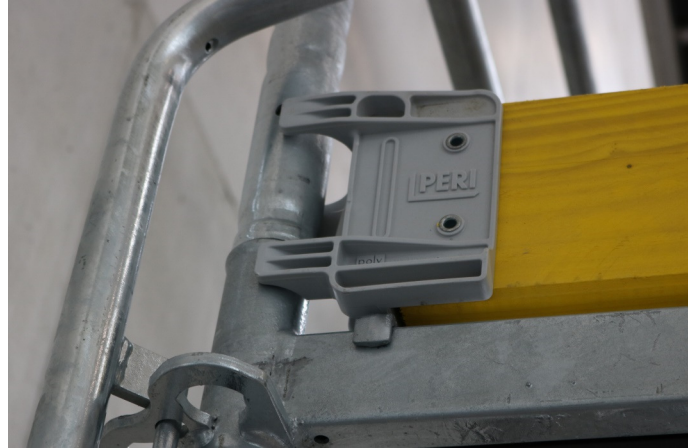
<p>33.40.22 Prongs broken off</p>

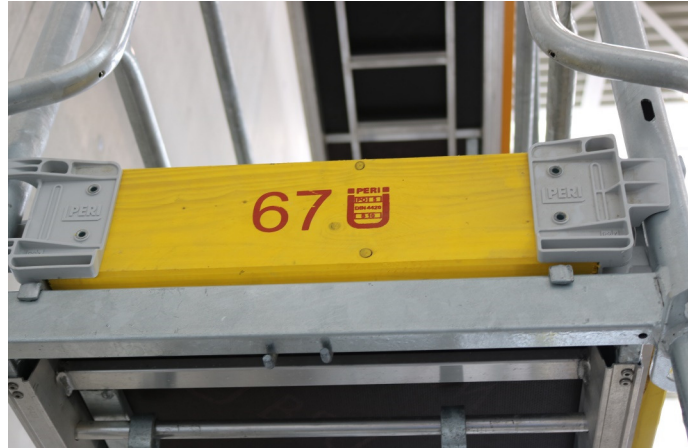
<p>33.40.23 Toeboard</p> <ul style="list-style-type: none"> ■ Broken due to violence

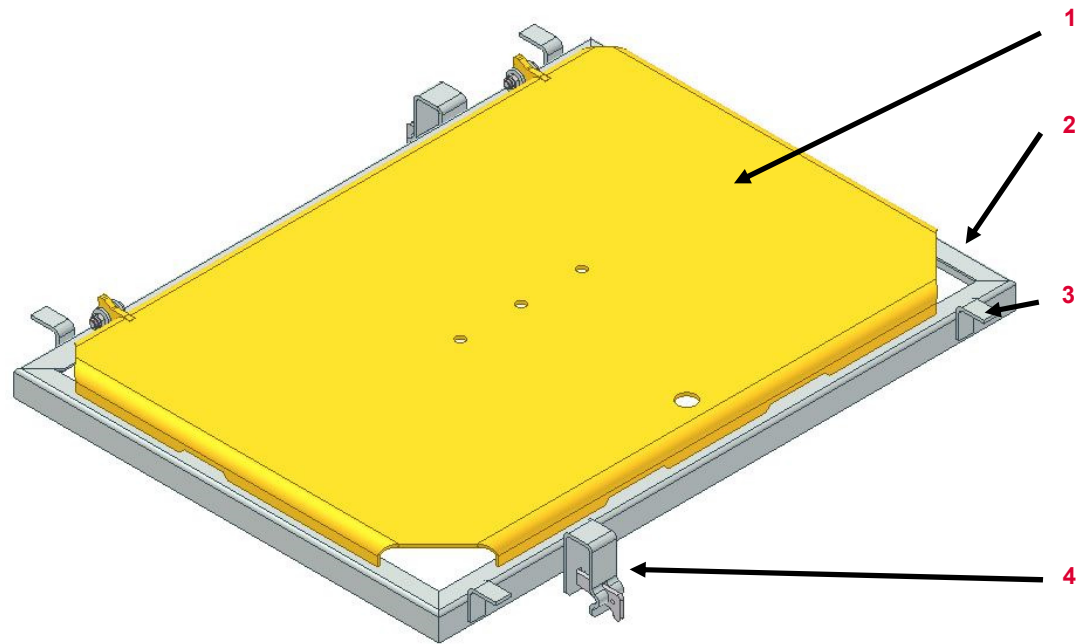
Hatch UAF Bottom Sheeting UDP	Nr.	Description	Article number
---------------------------------	-----	-------------	----------------

1	Cover	
2	Frame	
3	Hook	
4	Bracket

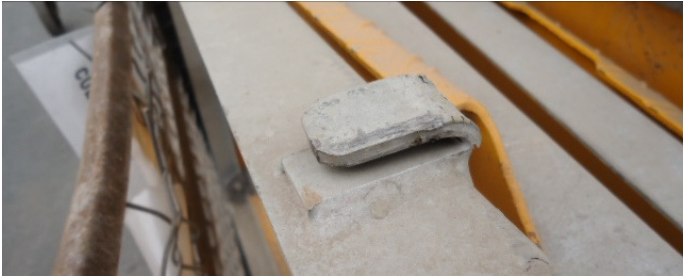
33.40.24 Hook massively deformed, torn out

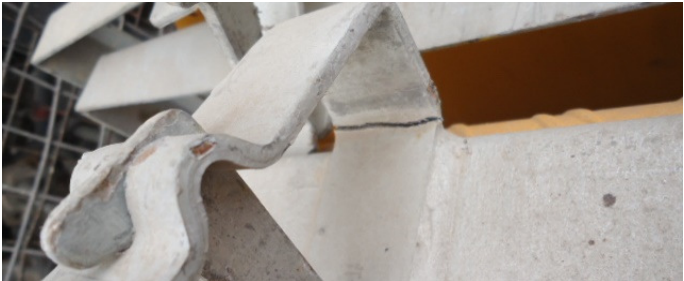
33.40.25 Bracket cracked

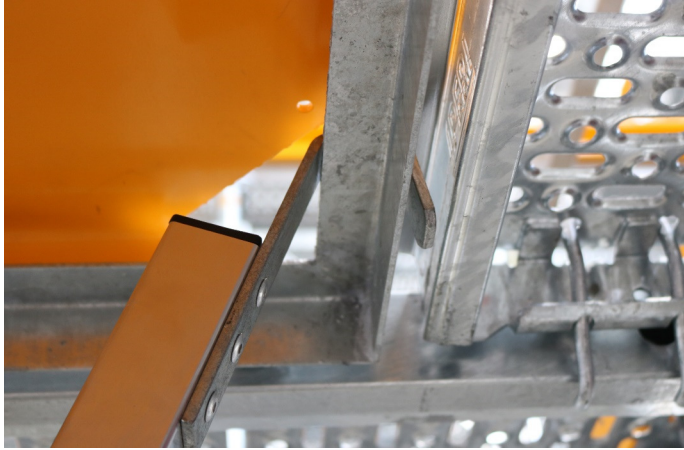
33.40.27 Hook bent	<ul style="list-style-type: none"> ■ If possible

<ul style="list-style-type: none"> ■ Or if not possible

<ul style="list-style-type: none"> ■ Or cracks in zinc layer

088244

109875 (Bracket) 104280 (Rivet)

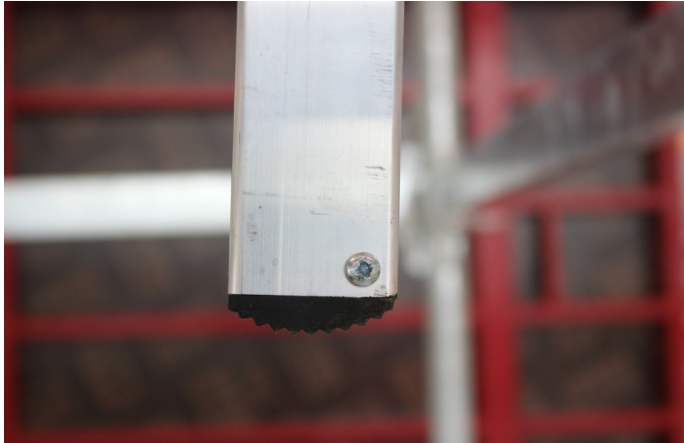
33.40.28 Cover	<ul style="list-style-type: none"> ■ Missing

<ul style="list-style-type: none"> ■ Or broken

110561 (Cover) 125661 (Screw)

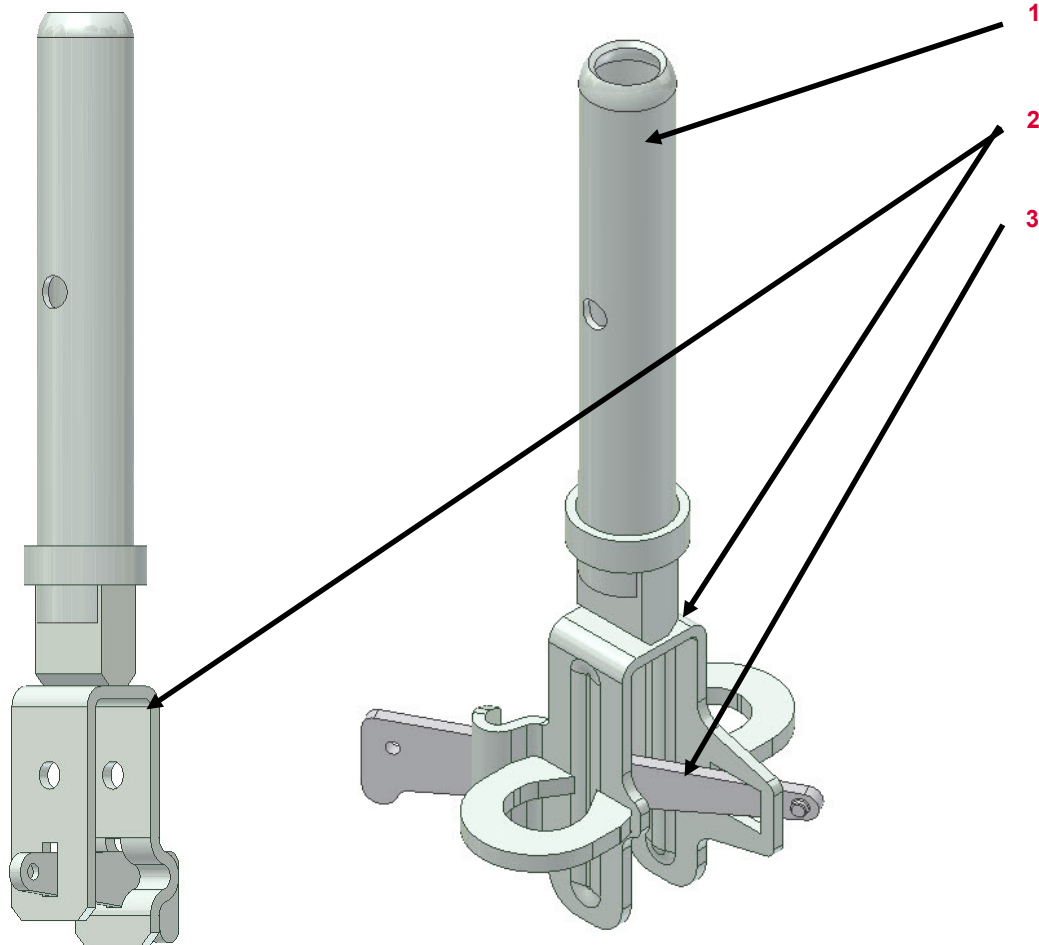
UH Spigot Ledger to Ledger Coupler	Nr.	Description	Article number
--------------------------------------	-----	-------------	----------------

1	Spigot	
2	Bracket	
3	Wedge

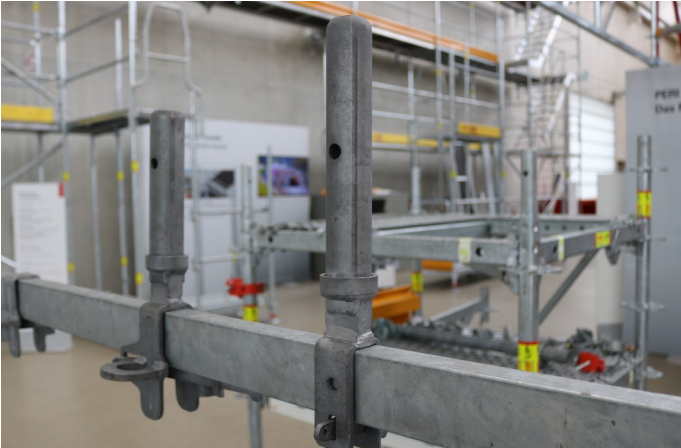
33.40.29 Spigot bent | dented

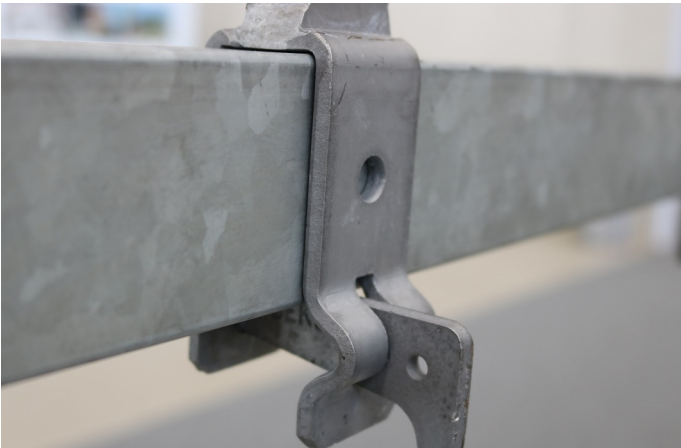
33.40.30 Hook bent

■ If possible and no cracks in zinc layer

■ Or if no longer possible

088244

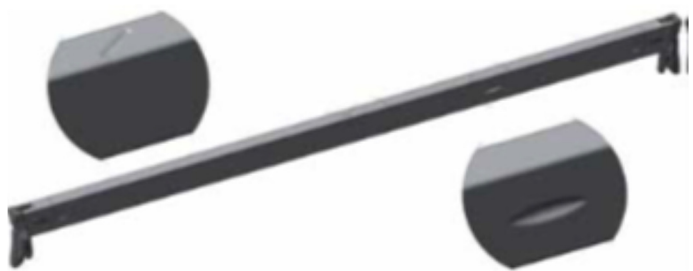
<p>33.40.31 Local dent in profile</p> <ul style="list-style-type: none"> ■ Edges not affected

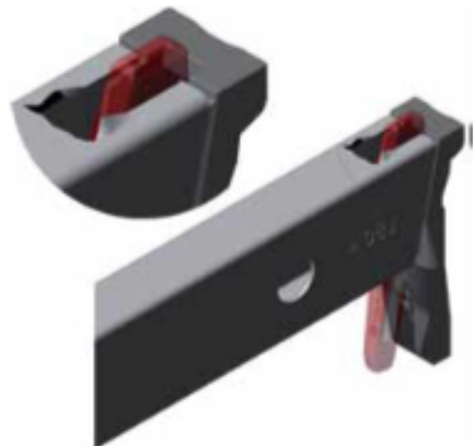
<p>33.40.32 Wedge torn out missing</p>

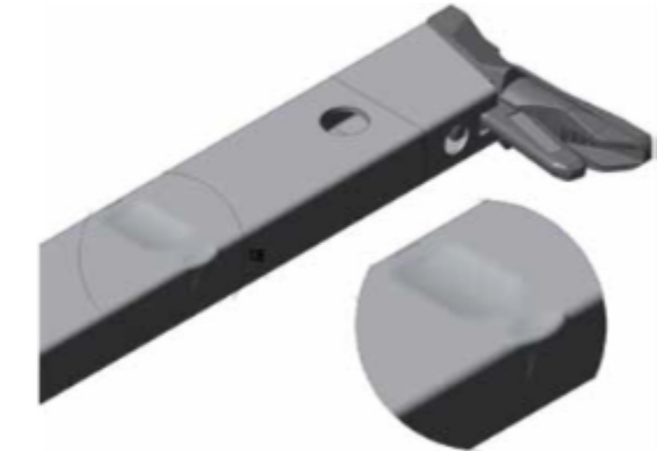
33.40.33 Profile bent at edge

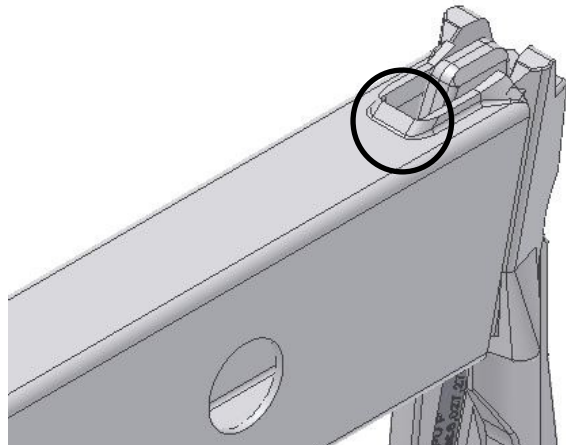
33.40.34 Dent at hook

- If possible

- Or if not possible

- Or crack in material

088244

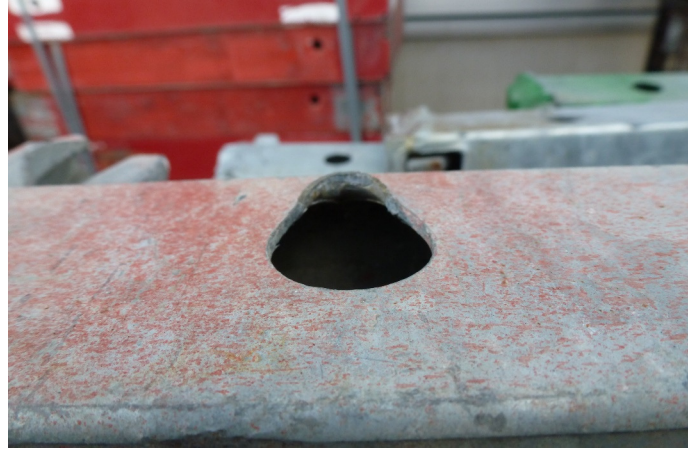
33.40.35 Hole dented			
	<ul style="list-style-type: none"> ■ If original geometry of hole unchanged

<ul style="list-style-type: none"> ■ Or if changed

<ul style="list-style-type: none"> ■ Or cracks in material

088244

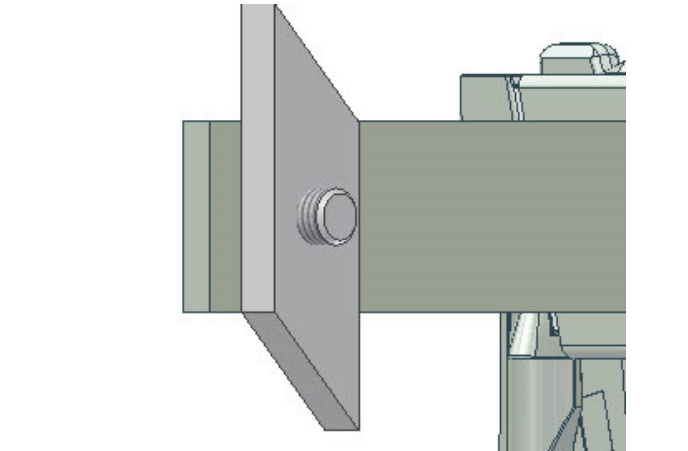
33.40.36 Clamping plate			
	<ul style="list-style-type: none"> ■ Missing

<ul style="list-style-type: none"> ■ Or not movable

701763 (Clamping plate) 710266 (Bolt)

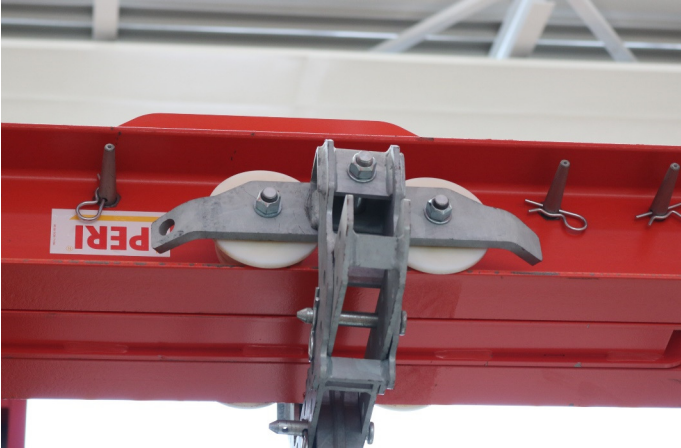
33.40.37 Flanged Wheel <ul style="list-style-type: none"> ■ Timeworn

<ul style="list-style-type: none"> ■ Damaged due to violence

127436 (Flanged Wheel)

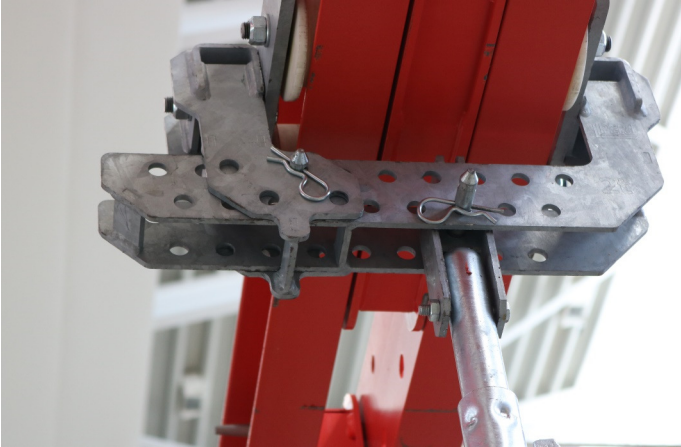
33.40.38 Bolt Cotter pin <ul style="list-style-type: none"> ■ Missing

<ul style="list-style-type: none"> ■ Unusable due to violence

018050 (Bolt) 018060 (Spring pin)

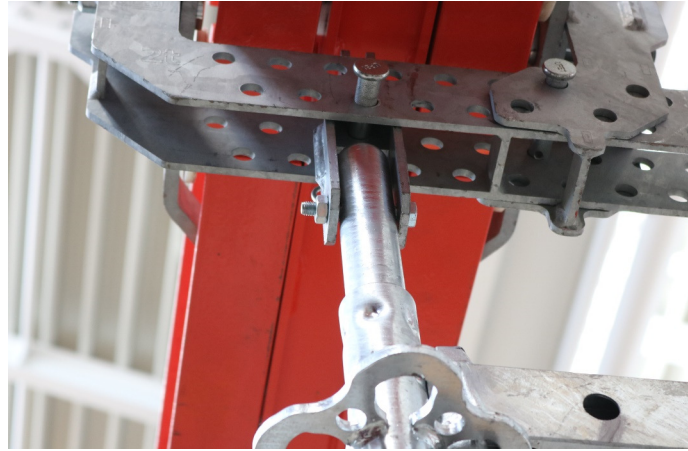
33.40.39 Spigot connection bent	<ul style="list-style-type: none"> <li data-bbox="875 568 1249 595">■ If possible (connection possible)

<ul style="list-style-type: none"> <li data-bbox="875 711 1084 738">■ Or if not possible

088244

127447 (Spigot connection)

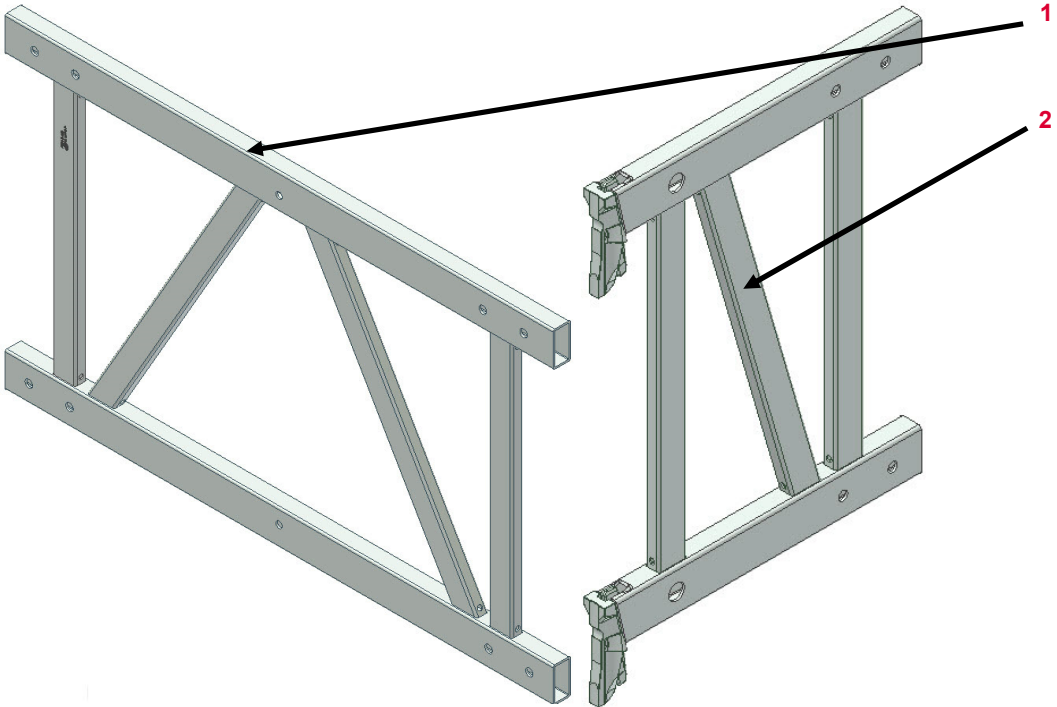
Additional Element End Element ULS Flex	Nr.	Description	Article number
---	-----	-------------	----------------

- 1 Frame
- 2 Strut

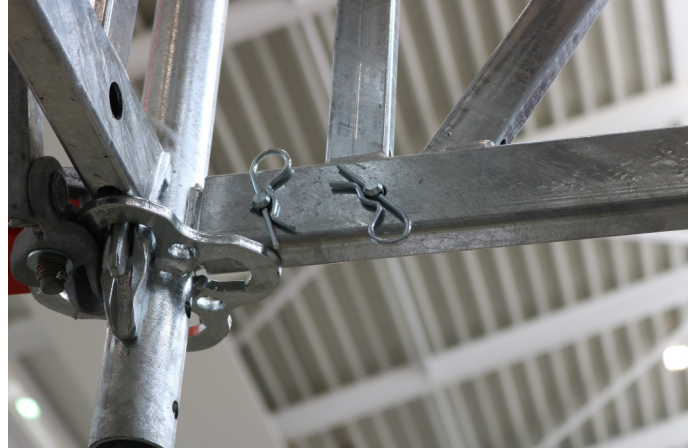
<p>33.40.40 Elements bent dented at junction</p> <ul style="list-style-type: none"> ■ If possible and bolts are able to be put through ■ Or no longer possible ■ Or cracks in zinc layer 	<ul style="list-style-type: none">

088244

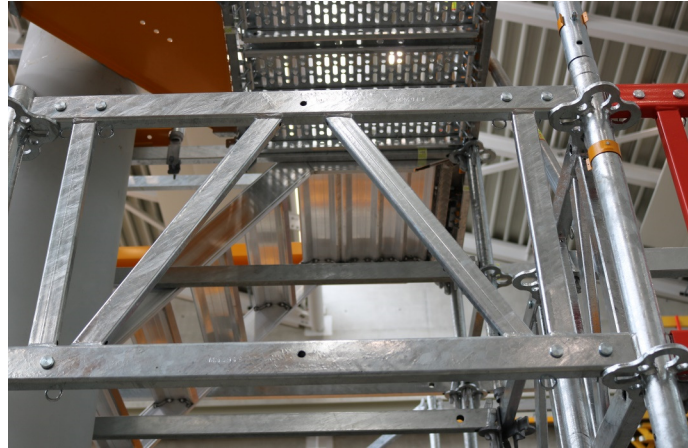
<p>33.40.41 Frame strut bent</p> <ul style="list-style-type: none"> ■ Functionality given ■ Or functionality no longer given ■ Or bent 	<ul style="list-style-type: none">

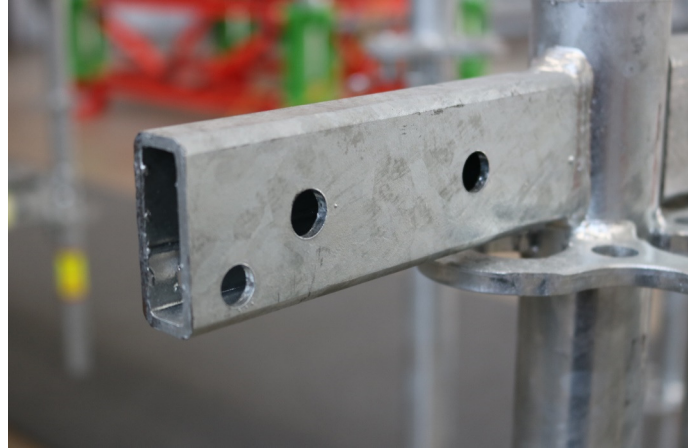
<p>33.40.42 Junctions bent</p> <ul style="list-style-type: none"> ■ If possible and bolts are able to be put through ■ Or no longer possible ■ Or cracks in zinc layer 	<p>

088244

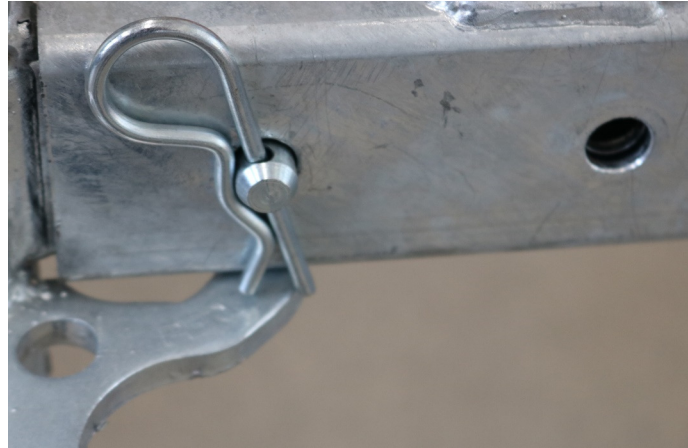
<p>33.40.43 Bolt / Cotter pin</p> <ul style="list-style-type: none"> ■ Missing ■ Unusable due to violence 	<p>

018060 (Cotter pin) 124771 (Bolt)

018060 (Cotter pin) 124771 (Bolt) </p>	<p>
